## General Information

| Make | Toyota | Model | Vios |
| YOM | 2024 | Odo Meter Reading | 13,909 |

## Body / Panel Condition

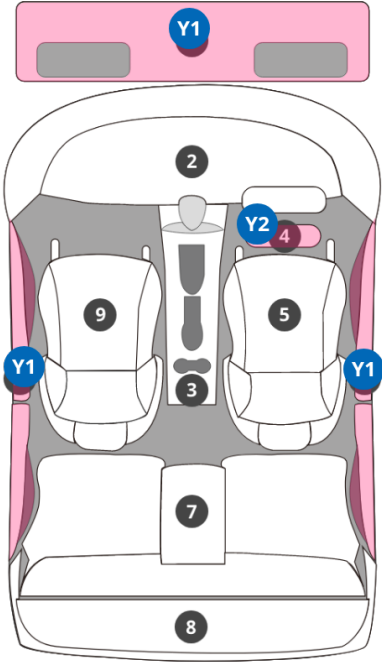
| Interior Evaluation : <span style="color: red; font-weight: bold;">A</span> | Exterior Evaluation : <span style="color: red; font-weight: bold;">B</span> |
| <b>Remarks</b><br>(R) Front Trim - Grime - Minimal / (L) Front Trim - Grime - Minimal / (L) Front Floor Mat - Grime - Small / Ceiling - Grime - Minimal | <b>Remarks</b><br>(L) Rear Door - Repair Traces - Yes / Front Bumper, Grille, Lamps - Scratch & Dent - Small / (L) Mirror - Scratch - Minimal / (L) Front Fender, Molding - Scratch - Minimal / (L) Rear Fender, Molding - Scratch - Small / (L) Front Door, Molding - Scratch - Minimal / Trunk Hood, Rear Gate - Scratch - Medium / (R) Rear Door, Molding - Scratch - Minimal / (R) Mirror - Scratch - Small |
