General Information

Make	Suzuki	Model	Swift
YOM	2016	Odo Meter Reading	88,329
Registration No.	GED9975	Chassis No.	MA3ZC62S6HAA93600
CC	1.2	Transmission	A/T
Fuel Type	Gas	Type of Body	Hatchback
Colour	Silver

Body / Panel Condition

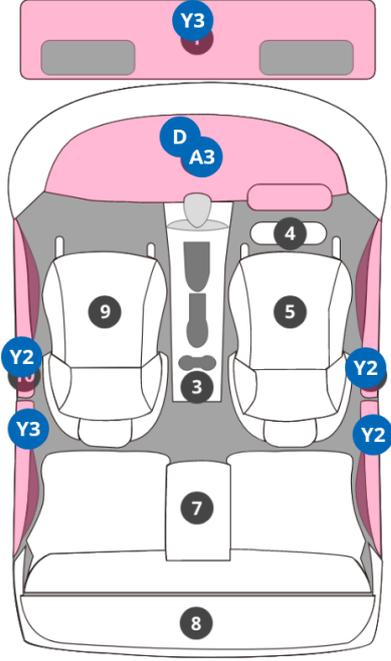
Interior Evaluation : C	Exterior Evaluation : E

<p>a : Cut, Fray d : Loose, Deformed k : Animal Hair s : Smell t : Cigarette Burns x : Defective y : Stain</p>

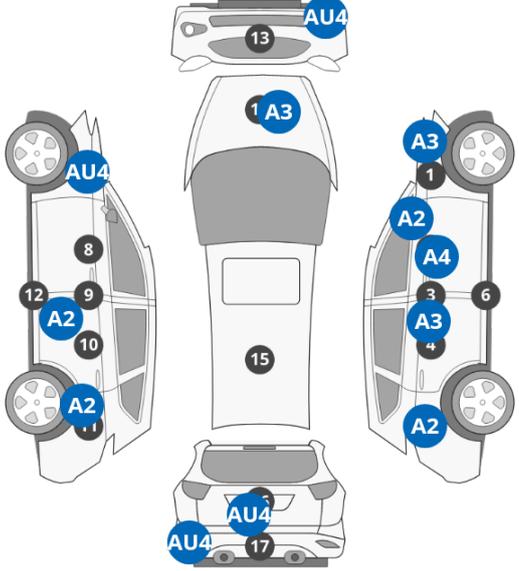
<p>A : Scratch AU : Scratch & Dent B : Modified C : Corrosion G : Stone chip P : Faded S : Rust SC : Rust & Corrosion U : Dent X : Defective Y : Crack, Gap</p>
<p>Remarks Ceiling - Grime - Medium / Dashboard - Worn, Scratch, Cut, Crack - Medium / Dashboard - Traces of Adhesive Tape - Yes / (R) Front Trim - Grime - Small / (R) Rear Trim - Grime - Small / (L) Rear Trim - Grime - Medium / (L) Front Trim - Grime - Small</p>	<p>Remarks (R) Rear Door - Repair Traces - Yes / Bonnet, Headlight - Scratch - Medium / (R) Front Fender, Molding - Scratch - Medium / (R) Mirror - Scratch - Small / (R) Front Door, Molding - Scratch - Large / (R) Rear Door, Molding - Scratch - Medium / (R) Rear Fender, Molding - Scratch - Small / Trunk Hood, Rear Gate - Scratch & Dent - Large / Rear Bumper, Lamps, Panels - Scratch & Dent - Large / (L) Rear Fender, Molding - Scratch - Small / (L) Rear Door, Molding - Scratch - Small / (L) Front Fender, Molding - Scratch & Dent - Large / Front Bumper, Grille, Lamps - Scratch & Dent - Large</p>
