General Information

Make	Toyota	Model	Hilux
YOM	2025	Odo Meter Reading	12,739
Registration No.	DBQ6723	Chassis No.	MR0JB8DD8R3233051
CC	2.4	Transmission	A/T
Fuel Type	Diesel	Type of Body	Pickup
Colour	Silver

Body / Panel Condition

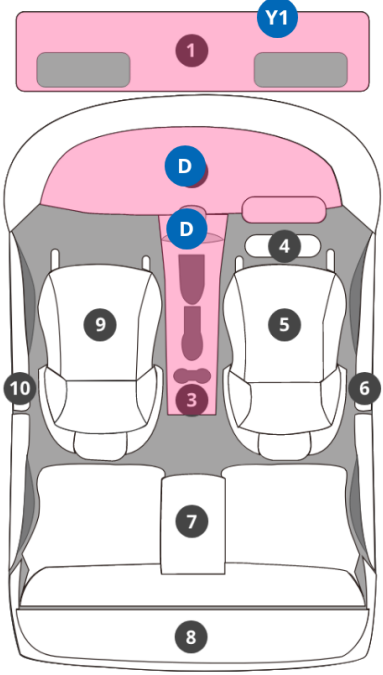
Interior Evaluation : A	Exterior Evaluation : C

<p>a : Cut, Fray d : Loose, Deformed k : Animal Hair s : Smell t : Cigarette Burns x : Defective y : Stain</p>

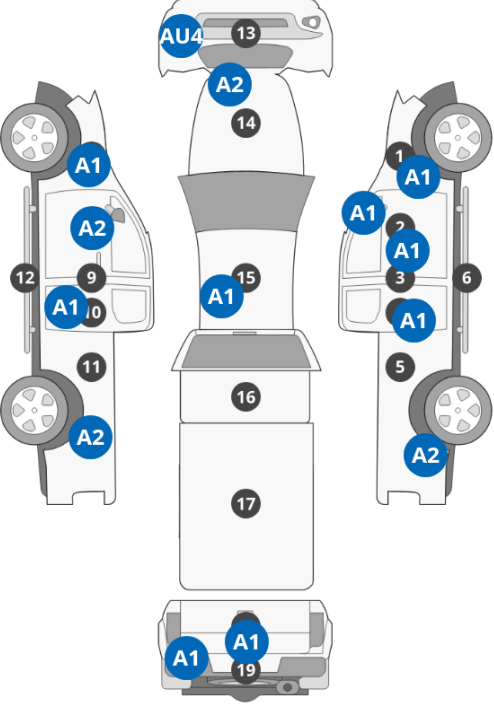
<p>A : Scratch AU : Scratch & Dent B : Modified C : Corrosion G : Stone chip P : Faded S : Rust SC : Rust & Corrosion U : Dent X : Defective Y : Crack, Gap</p>
<p>Remarks Dashboard - Traces of Adhesive Tape - Yes / Console, Switches, Vents - Traces of Adhesive Tape - Yes / Ceiling - Grime - Minimal</p>	<p>Remarks (R) Mirror - Scratch - Minimal / (R) Front Fender, Molding - Scratch - Minimal / (R) Front Door, Molding - Scratch - Minimal / (R) Side Gate - Scratch - Small / (R) Rear Door, Molding - Scratch - Minimal / Rear Bumper, Lamps, Panels - Scratch - Minimal / Rear Gate - Scratch - Minimal / (L) Side Gate - Scratch - Small / (L) Front Door, Molding - Scratch - Small / (L) Rear Door, Molding - Scratch - Minimal / (L) Front Fender, Molding - Scratch - Minimal / Front Bumper, Grille, Lamps - Scratch & Dent - Large / Bonnet, Headlight - Scratch - Small / Roof - Scratch - Minimal</p>

<p>Inspector Notes</p>
<p>no warranty booklet, with jack and tools, with spare tire, with LTO plate, minor scratches on headlight and tail light</p>
