## General Information

| Make | Toyota | Model | Raize |
| YOM | 2024 | Odo Meter Reading | 53,134 |
| Registration No. | NKE1162 | Chassis No. | MHKAB1BAXRJ091172 |

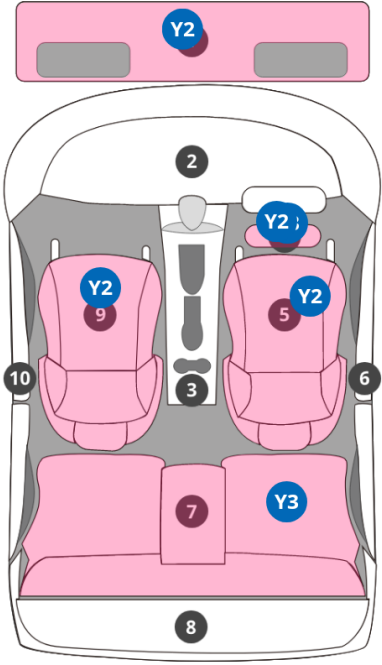
| Interior Evaluation : <b>B</b> | Exterior Evaluation : <b>E</b> |
|---|---|
| <b>Remarks</b><br>(R) Front Floor Mat - Grime - Medium / (R) Front Seat - Grime - Small / Rear Seat - Grime - Medium / (L) Front Seat - Grime - Small / (L) Front Floor Mat - Grime - Small / Ceiling - Grime - Small | <b>Remarks</b><br>Rear Bumper, Lamps, Panels - Scratch & Dent - Large / (L) Rear Fender, Molding - Scratch & Dent - Medium / Trunk Hood, Rear Gate - Scratch & Dent - Large / (R) Rear Fender, Molding - Scratch - Small / (R) Rear Door, Molding - Scratch - Medium / (R) Front Door, Molding - Scratch - Small / (R) Front Fender, Molding - Scratch & Dent - Small / (R) Mirror - Scratch - Minimal / Front Bumper, Grille, Lamps - Scratch - Medium / (L) Mirror - Scratch - Minimal / Bonnet, Headlight - Scratch - Small / (L) Front Fender, Molding - Scratch - Small / (L) Front Door, Molding - Scratch & Dent - Large / (L) Rear Door, Molding - Scratch & Dent - Large / Roof - Dent - Small |
