## General Information

| Make | Toyota | Model | Vios |
| Registration No. | EAJ3403 | Chassis No. | PA1B18F39P4230794 |

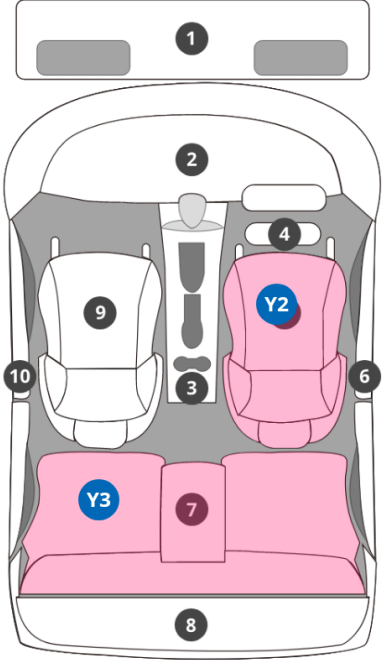
| Interior Evaluation : <b>B</b> | Exterior Evaluation : <b>B</b> |
| <b>Remarks</b><br>Rear Seat - Grime - Medium / (R) Front Seat - Grime - Small | <b>Remarks</b><br>(R) Mirror - Scratch - Small / Rear Bumper, Lamps, Panels - Dent - Minimal / (L) Rear Fender, Molding - Scratch - Small / Front Bumper, Grille, Lamps - Scratch & Dent - Small / (R) Step, In-panel, Side Spoiler - Scratch - Small / (R) Front Door, Molding - Scratch - Small |
