## General Information

| Make | Toyota | Model | Raize |
| YOM | 2025 | Odo Meter Reading | 12,959 |
| Registration No. | NOA4556 | Chassis No. | MHKAB1BA1SJ117129 |

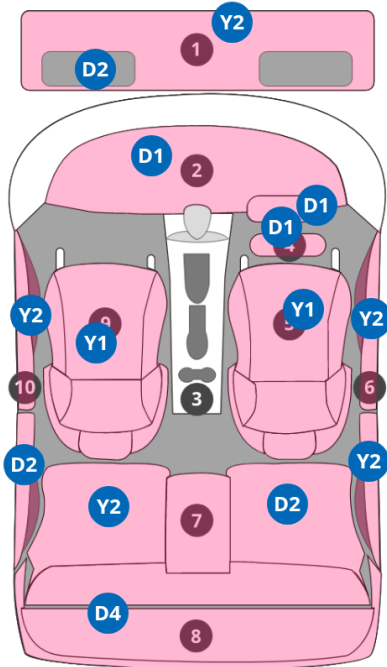
| Interior Evaluation : <span style="color: red;">C</span> | Exterior Evaluation : <span style="color: red;">D</span> |
| <b>Remarks</b><br>Dashboard - Worked - Minimal / Carpet - Worked - Minimal / (L) Front Seat - Grime - Minimal / (R) Front Seat - Grime - Minimal / Rear Seat - Grime - Small / Rear Seat Head Rest - Worked - Small / Trunk Room - Worked - Large / Sunvisor, Sunglass Holder - Worked - Small / Ceiling - Grime - Small / (L) Front Trim - Grime - Small / (R) Front Trim - Grime - Small / (R) Rear Trim - Grime - Small / (L) Rear Trim - Worked - Small / Glove Box - Worked - Minimal | <b>Remarks</b><br>(L) Rear Fender - Repair Traces - Yes / (L) Rear Fender, Molding - Scratch & Dent - Medium / (L) Rear Door, Molding - Scratch & Dent - Medium / (L) Front Door, Molding - Scratch - Small / (L) Center Panel - Scratch - Minimal / Trunk Hood, Rear Gate - Scratch & Dent - Medium / (R) Rear Door, Molding - Scratch - Small / (R) Front Door, Molding - Scratch - Small / (R) Front Fender, Molding - Scratch - Small / Bonnet, Headlight - Scratch - Small / Front Bumper, Grille, Lamps - Scratch - Small / (R) Rear Fender, Molding - Scratch - Small / Roof - Scratch - Small / (R) Step, In-panel, Side Spoiler - Scratch - Small / (L) Front Fender, Molding - Scratch & Dent - Small |
