## General Information

<b>Make</b>	Toyota	<b>Model</b>	Vios
<b>YOM</b>	2024	<b>Odo Meter Reading</b>	39,636
<b>Registration No.</b>	NFR1926	<b>Chassis No.</b>	PA1B18F38R4247024
<b>CC</b>	1.3	<b>Transmission</b>	CVT
<b>Fuel Type</b>	Gas	<b>Type of Body</b>	Sedan
<b>Colour</b>	Black

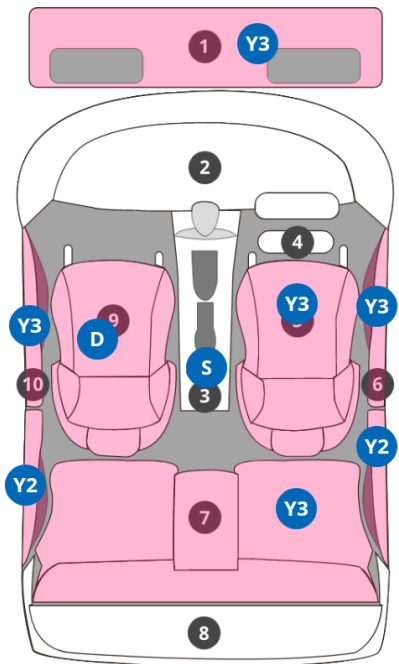
<b>Interior Evaluation :</b> <span style="float: right; color: red; font-weight: bold;">C</span>	<b>Exterior Evaluation :</b> <span style="float: right; color: red; font-weight: bold;">E</span>

<p><b>a :</b> Cut, Fray <b>d :</b> Loose, Deformed <b>k :</b> Animal Hair <b>s :</b> Smell <b>t :</b> Cigarette Burns <b>x :</b> Defective <b>y :</b> Stain</p>

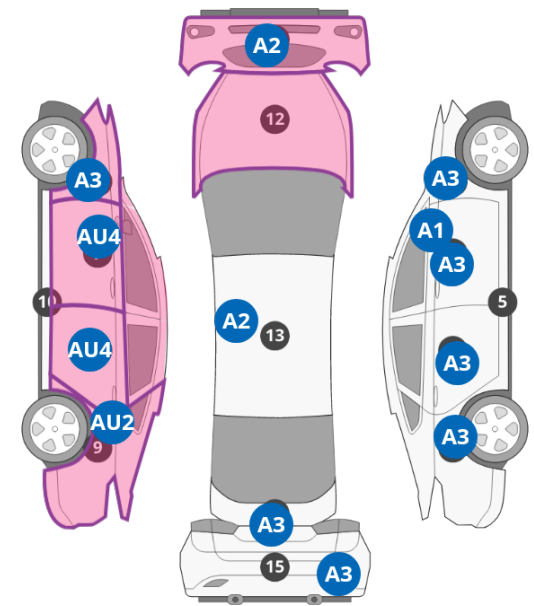
<p><b>A :</b> Scratch <b>AU :</b> Scratch &amp; Dent <b>B :</b> Modified <b>C :</b> Corrosion <b>G :</b> Stone chip <b>P :</b> Faded <b>S :</b> Rust <b>SC :</b> Rust &amp; Corrosion <b>U :</b> Dent <b>X :</b> Defective <b>Y :</b> Crack, Gap</p>
<p><b>Remarks</b> Ceiling - Grime - Medium / (L) Front Trim - Grime - Medium / (R) Front Seat - Grime - Medium / (R) Front Trim - Grime - Medium / Rear Seat - Grime - Medium / (R) Rear Trim - Grime - Small / (L) Rear Trim - Grime - Small / (L) Front Seat - Worn - Yes / Overall Interior - Smell - Yes</p>	<p><b>Remarks</b> (R) Front Door - Repair Traces - Yes / Bonnet - Repair Traces - Yes / (L) Front Fender - Repair Traces - Yes / (L) Front Door - Repair Traces - Yes / (L) Step - Repair Traces - Yes / (L) Rear Door - Repair Traces - Yes / (L) Rear Fender - Repair Traces - Yes / Trunk Hood, Rear Gate - Repair Traces - Yes / (R) Front Fender, Molding - Scratch - Medium / (R) Front Door, Molding - Scratch - Medium / (R) Mirror - Scratch - Minimal / (R) Rear Door, Molding - Scratch - Medium / (R) Rear Fender, Molding - Scratch - Medium / Rear Bumper, Lamps, Panels - Scratch - Medium / Trunk Hood, Rear Gate - Scratch - Medium / (L) Rear Fender, Molding - Repair mark - Yes / (L) Rear Fender, Molding - Scratch &amp; Dent - Small / (L) Rear Door, Molding - Scratch &amp; Dent - Large / (L) Rear Door, Molding - Repair mark - Difference in Color / (L) Front Door, Molding - Scratch &amp; Dent - Large / (L) Front Door, Molding - Repair mark - Yes / (L) Front Fender, Molding - Scratch - Medium / (L) Front Fender, Molding - Repair mark - Yes / Roof - Scratch - Small / Overall Exterior - Faded(Color, Gloss) - Yes / Bonnet, Headlight - Repair mark - Yes / Front Bumper, Grille, Lamps - Scratch - Small / Front Bumper, Grille, Lamps - Repair mark - Yes</p>
