General Information

Make	Toyota	Model	Hiace
YOM	2024	Odo Meter Reading	108,329
Registration No.	NHG5834	Chassis No.	JTFJT02P6P5035541
CC	3.0	Transmission	M/T
Fuel Type	Diesel	Type of Body	Van
Colour	White

Body / Panel Condition

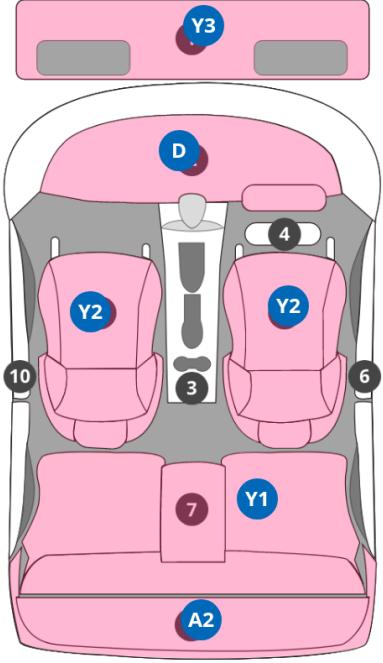
Interior Evaluation : B	Exterior Evaluation : E

<p>a : Cut, Fray d : Loose, Deformed k : Animal Hair s : Smell t : Cigarette Burns x : Defective y : Stain</p>

<p>A : Scratch AU : Scratch & Dent B : Modified C : Corrosion G : Stone chip P : Faded S : Rust SC : Rust & Corrosion U : Dent X : Defective Y : Crack, Gap</p>
<p>Remarks (R) Front Seat - Grime - Small / (L) Front Seat - Grime - Small / Dashboard - Traces of Adhesive Tape - Yes / Rear Seat - Grime - Minimal / Trunk Room - Worn, Scratch, Cut, Crack - Small / Ceiling - Grime - Medium</p>	<p>Remarks (L) Rear Fender - Repair Traces - Yes / Trunk Hood, Rear Gate - Dent - Large / Rear Bumper, Lamps, Panels - Scratch & Dent - Medium / (R) Rear Fender, Molding - Scratch & Dent - Medium / (R) Rear Door, Molding - Scratch & Dent - Large / (R) Front Door, Molding - Scratch - Small / Front Panel - Scratch - Minimal / Front Bumper, Grille, Lamps - Scratch - Medium / (L) Mirror - Scratch - Small / (L) Front Door, Molding - Scratch - Medium / (L) Rear Door, Molding - Scratch & Dent - Large / (L) Rear Fender, Molding - Scratch & Dent - Large / Roof - Scratch & Dent - Large</p>
