## General Information

| Make | Toyota | Model | Vios |
| YOM | 2023 | Odo Meter Reading | 112,545 |
| Registration No. | NHJ5410 | Chassis No. | PA1B18F38P4216191 |

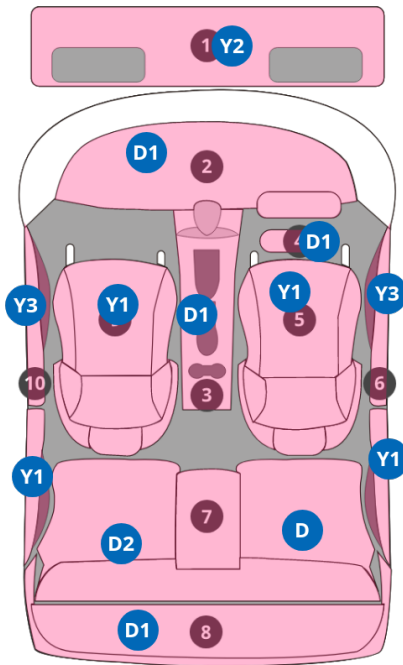
| Interior Evaluation : <span style="color: red;">C</span> | Exterior Evaluation : <span style="color: red;">E</span> |
| <p><b>Remarks</b></p> <p>Dash-board - Worked - Minimal / (L) Front Seat - Grime - Minimal / (R) Front Seat - Grime - Minimal / (L) Front Trim - Grime - Medium / (L) Rear Trim - Grime - Minimal / Rear Seat Head Rest - Worked - Small / Trunk Room - Worked - Minimal / Console, Switchs, Vents - Worked - Minimal / (R) Rear Trim - Grime - Minimal / Carpet - Worked - Minimal / (R) Front Trim - Grime - Medium / Ceiling - Grime - Small / Rear Seat - Worn - Yes</p> | <p><b>Remarks</b></p> <p>Bonnet, Headlight - Scratch - Small / Rear Bumper, Lamps, Panels - Scratch &amp; Dent - Medium / Trunk Hood, Rear Gate - Scratch - Medium / Roof - Scratch &amp; Dent - Small / (R) Front Fender, Molding - Scratch &amp; Dent - Large / Front Bumper, Grille, Lamps - Scratch - Medium / (L) Front Door, Molding - Scratch &amp; Dent - Small / (L) Rear Door, Molding - Scratch &amp; Dent - Small / (L) Step, In-panel, Side Spoiler - Scratch - Small / (L) Rear Fender, Molding - Scratch - Small / (R) Rear Fender, Molding - Scratch - Small / (R) Rear Door, Molding - Scratch - Medium / (R) Step, In-panel, Side Spoiler - Scratch - Small / (R) Front Door, Molding - Scratch &amp; Dent - Small / (L) Front Fender, Molding - Scratch - Small</p> |
