## General Information

| Make | Toyota | Model | Rush |
| Registration No. | NHI5393 | Chassis No. | MHKE8FF3PPK053239 |

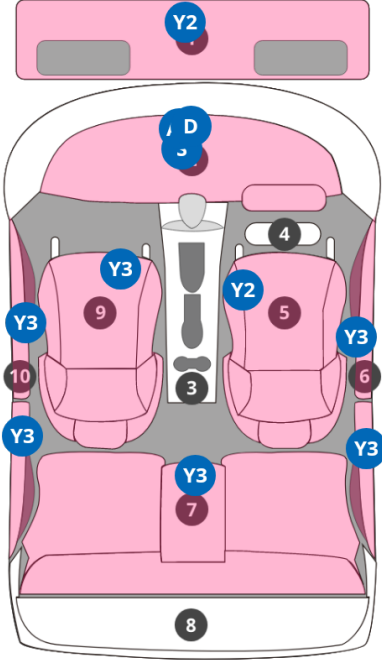
| Interior Evaluation : <b>C</b> | Exterior Evaluation : <b>E</b> |
| <p><b>Remarks</b></p> <p>Rear Seat - Grime - Medium / (R) Front Seat - Grime - Small / (L) Front Seat - Grime - Medium / Ceiling - Grime - Small / (R) Rear Trim - Grime - Medium / (L) Rear Trim - Grime - Medium / (L) Front Trim - Grime - Medium / (R) Front Trim - Grime - Medium / Overall Interior - Smell - Yes / Dashboard - Traces of Adhesive Tape - Yes</p> | <p><b>Remarks</b></p> <p>(L) Front Fender - Repair Traces - Yes / (R) Front Fender, Molding - Scratch - Small / (R) Mirror - Faded(Color, Gloss) - Yes / (R) Mirror - Scratch - Small / (R) Front Door, Molding - Scratch - Small / (R) Rear Door, Molding - Scratch &amp; Dent - Minimal / Overall Exterior - Worn as per age - Yes / (R) Rear Fender, Molding - Scratch - Small / Rear Bumper, Lamps, Panels - Scratch &amp; Dent - Medium / Trunk Hood, Rear Gate - Scratch - Medium / (L) Rear Fender, Molding - Scratch - Small / (L) Rear Door, Molding - Scratch &amp; Dent - Small / (L) Front Door, Molding - Scratch - Small / (L) Front Fender, Molding - Scratch &amp; Dent - Large / Front Bumper, Grille, Lamps - Crack, Gap - Large / Bonnet, Headlight - Scratch - Small / Roof - Scratch - Small / Member (Bolted) - Dent - Yes</p> |

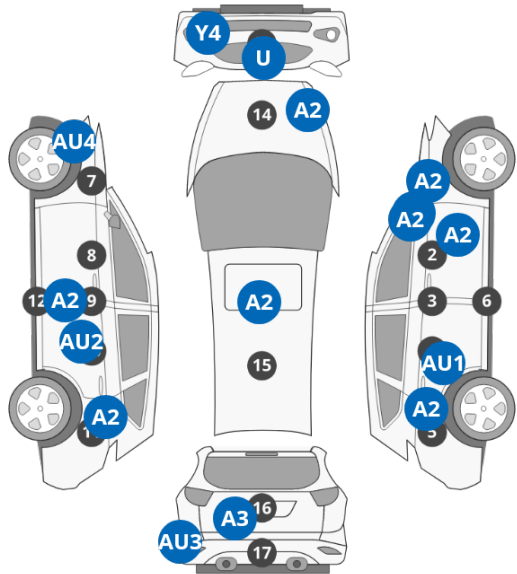
| Inspector Notes |
|---|
| with warranty booklet, with jack and tools, with spare tire, with LTO plate, scratches on headlight and tail light, plate light issue |
