General Information

Make	Toyota	Model	Hiace
YOM	2020	Odo Meter Reading	58,182
Registration No.	CAV2651	Chassis No.	JTFJT02P0K5023376
CC	3.0	Transmission	M/T
Fuel Type	Diesel	Type of Body	Van
Colour	White

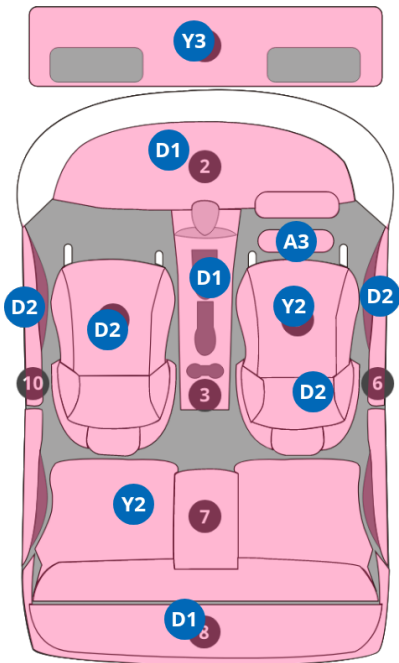
Interior Evaluation : C	Exterior Evaluation : D

<p>a : Cut, Fray d : Loose, Deformed k : Animal Hair s : Smell t : Cigarette Burns x : Defective y : Stain</p>

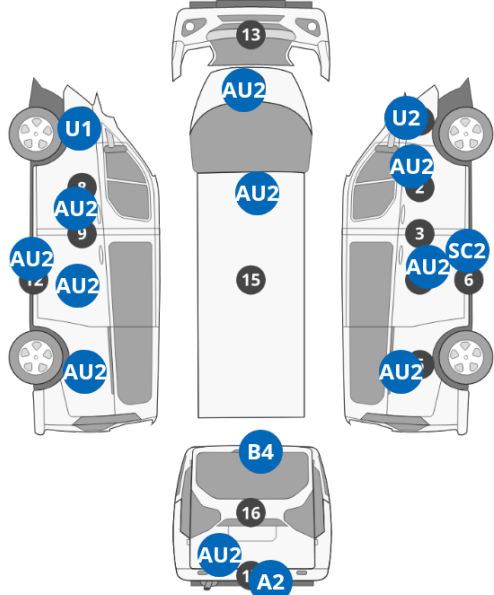
<p>A : Scratch AU : Scratch & Dent B : Modified C : Corrosion G : Stone chip P : Faded S : Rust SC : Rust & Corrosion U : Dent X : Defective Y : Crack, Gap</p>
<p>Remarks (L) Front Floor Mat - Cut, Crack - Medium / (L) Front Trim - Worked - Small / Rear Seat - Grime - Small / Trunk Room - Worked - Minimal / (R) Front Seat - Grime - Small / Dashboard - Worked - Minimal / Console, Switches, Vents - Worked - Minimal / Ceiling - Grime - Medium / (L) Front Seat Head Rest - Worked - Small / (R) Front Seat Head Rest - Worked - Small / (R) Front Trim - Worked - Small</p>	<p>Remarks (R) Step - Repair Traces - Yes / Bonnet - Repair Traces - Yes / (L) Step - Repair Traces - Yes / Trunk Hood, Rear Gate - Repair Traces - Yes / (R) Rear Door - Repair Traces - Yes / Roof - Scratch & Dent - Small / Bonnet, Headlight - Scratch & Dent - Small / (L) Front Fender, Molding - Dent - Minimal / (R) Front Fender, Molding - Dent - Small / (R) Front Door, Molding - Scratch & Dent - Small / (R) Rear Door, Molding - Scratch & Dent - Small / (R) Rear Fender, Molding - Scratch & Dent - Small / Trunk Hood, Rear Gate - Scratch & Dent - Small / Trunk Hood, Rear Gate - Modified - Large / (L) Rear Fender, Molding - Scratch & Dent - Small / (L) Rear Door, Molding - Scratch & Dent - Small / (L) Front Door, Molding - Scratch & Dent - Small / (L) Step, In-panel, Side Spoiler - Scratch & Dent - Small / (R) Step, In-panel, Side Spoiler - Rust, Corrosion - Small / Rear Bumper, Lamps, Panels - Scratch - Small</p>

<p>Inspector Notes</p>
<p>with LTO plate, with spare key, no warranty & manual booklet, no spare tire & tools, no reverse camera, radio unit issue, foglamp issue, signal light front issue, map/dome light issue, dashboard modified, engine modified, rear trunk interior issue, passenger side slide handle door issue, scratches on taillight.</p>
