General Information

Make	Toyota	Model	Wigo
YOM	2022	Odo Meter Reading	37,230
Registration No.	NFL4786	Chassis No.	MHKA4DF5FNJ068496
CC	1.0	Transmission	A/T
Fuel Type	Gas	Type of Body	Hatchback
Colour	Silver

Body / Panel Condition

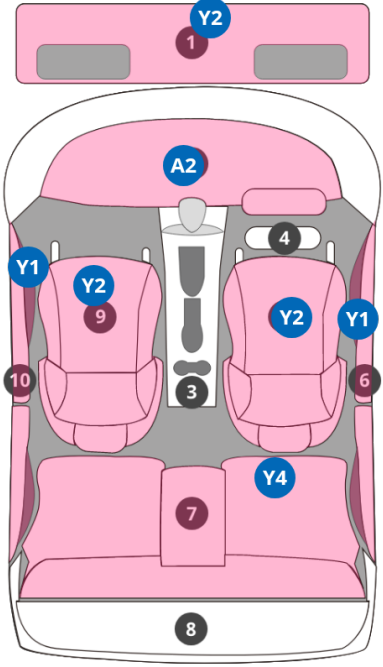
Interior Evaluation : C	Exterior Evaluation : C

<p>a : Cut, Fray d : Loose, Deformed k : Animal Hair s : Smell t : Cigarette Burns x : Defective y : Stain</p>

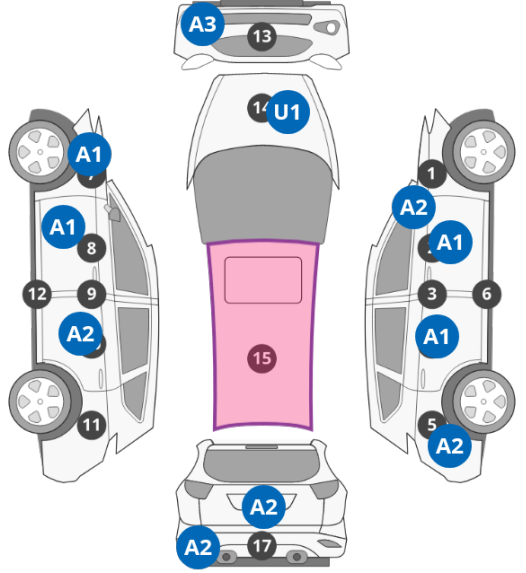
<p>A : Scratch AU : Scratch & Dent B : Modified C : Corrosion G : Stone chip P : Faded S : Rust SC : Rust & Corrosion U : Dent X : Defective Y : Crack, Gap</p>
<p>Remarks Rear Seat - Grime - Large / (R) Front Trim - Grime - Minimal / (R) Front Seat - Grime - Small / (L) Front Trim - Grime - Minimal / (L) Front Seat - Grime - Small / Ceiling - Grime - Small / Dashboard - Worn, Scratch, Cut, Crack - Small</p>	<p>Remarks Bonnet - Repair Traces - Yes / Rear Bumper, Lamps, Panels - Scratch - Small / (L) Rear Door, Molding - Scratch - Small / (L) Front Door, Molding - Scratch - Minimal / (L) Front Fender, Molding - Scratch - Minimal / Bonnet, Headlight - Dent - Minimal / Front Bumper, Grille, Lamps - Scratch - Medium / (R) Mirror - Scratch - Small / (R) Rear Fender, Molding - Scratch - Small / (R) Front Door, Molding - Scratch - Minimal / (R) Rear Door, Molding - Scratch - Minimal / Trunk Hood, Rear Gate - Scratch - Small / Roof - Repair mark - Yes</p>
