## General Information

| Make | Mitsubishi | Model | Mirage |
| YOM | 2019 | Odo Meter Reading | 60,823 |
| Registration No. | NDJ1791 | Chassis No. | PAEA13TXKKA006932 |

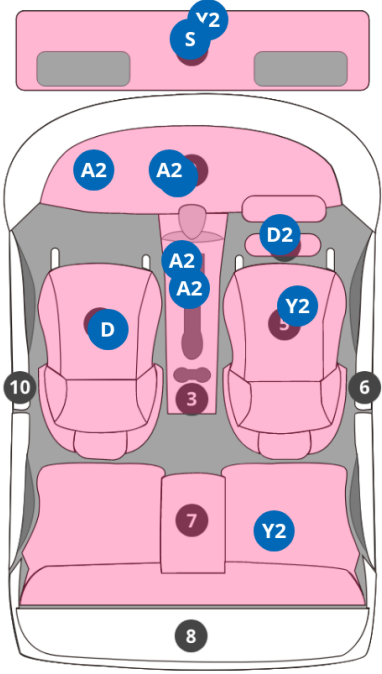
| Interior Evaluation : <b>C</b> | Exterior Evaluation : <b>E</b> |
| <b>Remarks</b><br>(L) Front Floor Mat - Worked - Small / Dashboard - Traces of Adhesive Tape - Yes / Dashboard - Worn, Scratch, Cut, Crack - Small / Steering Wheel - Worn, Peel, Crack - Small / Ceiling - Grime - Small / Overall Interior - Smell - Yes / Console, Switches, Vents - Worn, Scratch, Cut, Crack - Small / Knobs - Worn, Peel, Crack - Small / Room Mirror - Stuck - Yes / (L) Front Seat - Worn - Yes / (R) Front Seat - Grime - Small / Rear Seat - Grime - Small | <b>Remarks</b><br>(R) Front Door - Repair Traces - Yes / (R) Front Fender - Repair Traces - Yes / Bonnet - Repair Traces - Yes / (L) Front Fender - Repair Traces - Yes / (L) Front Door - Repair Traces - Yes / (L) Rear Door - Repair Traces - Yes / (L) Rear Fender - Repair Traces - Yes / Trunk Hood, Rear Gate - Repair Traces - Yes / (R) Rear Fender - Repair Traces - Yes / (R) Rear Door - Repair Traces - Yes / Roof - Repair Traces - Yes / Bonnet, Headlight - Repair mark - Yes / (R) Front Fender, Molding - Repair mark - Yes / (R) Front Door, Molding - Repair mark - Yes / (R) Rear Door, Molding - Repair mark - Yes / (R) Rear Fender, Molding - Repair mark - Yes / Trunk Hood, Rear Gate - Repair mark - Yes / (L) Rear Fender, Molding - Repair mark - Yes / (L) Rear Door, Molding - Repair mark - Yes / (L) Front Door, Molding - Repair mark - Yes / (L) Front Fender, Molding - Repair mark - Yes / Roof - Repair mark - Yes / (L) Front Fender, Molding - Scratch & Dent - Small / (L) Front Door, Molding - Scratch & Dent - Small / (L) Rear Door, Molding - Scratch - Small / (L) Mirror - Scratch - Minimal / (L) Rear Fender, Molding - Scratch & Dent - Minimal / (L) Step, In-panel, Side Spoiler - Scratch & Dent - Small / Front Bumper, Grille, Lamps - Scratch - Small / Member (Bolted) - Dent - Yes / Roof - Scratch & Dent - Small / (R) Front Fender, Molding - Scratch - Small / Bonnet, Headlight - Scratch - Medium / (R) Front Door, Molding - Scratch & Dent - Small / (R) Mirror - Scratch - Minimal / (R) Rear Door, Molding - Scratch - Small / (R) Step, In-panel, Side Spoiler - Scratch & Dent - Small / (R) Rear Fender, Molding - Scratch - Small / Rear Bumper, Lamps, Panels - Scratch - Medium / Trunk Hood, Rear Gate - Scratch - Small |
