## General Information

| Make | Mitsubishi | Model | Mirage |
| YOM | 2023 | Odo Meter Reading | 31,874 |
| Registration No. | NFA1061 | Chassis No. | PAEA13RXPPA015317 |

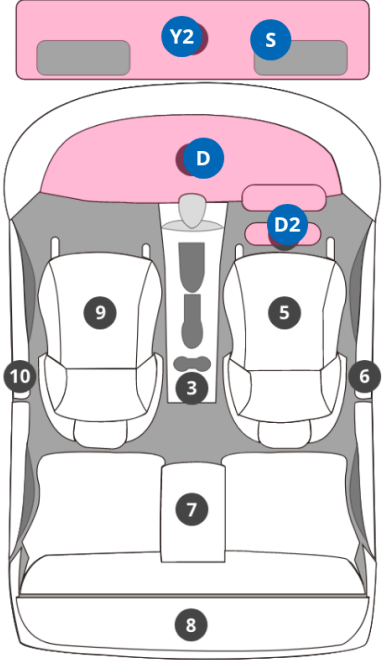
| Interior Evaluation : <b>B</b> | Exterior Evaluation : <b>C</b> |
| <b>Remarks</b><br>(L) Front Floor Mat - Worked - Small / Ceiling - Grime - Small / Dashboard - Traces of Adhesive Tape - Yes / Overall Interior - Smell - Yes | <b>Remarks</b><br>(R) Rear Door, Molding - Repair mark - Yes / (L) Front Fender, Molding - Scratch - Minimal / (L) Rear Door, Molding - Scratch & Dent - Small / (L) Front Door, Molding - Scratch & Dent - Small / (L) Rear Fender, Molding - Scratch - Small / (L) Step, In-panel, Side Spoiler - Scratch - Minimal / Bonnet, Headlight - Scratch & Dent - Small / Front Bumper, Grille, Lamps - Scratch - Small / (R) Front Door, Molding - Repair mark - Yes / (R) Mirror - Scratch - Minimal / (R) Front Fender, Molding - Scratch - Minimal / (R) Front Door, Molding - Scratch & Dent - Minimal / (R) Rear Door, Molding - Scratch - Small / Rear Bumper, Lamps, Panels - Scratch - Small / (R) Rear Fender, Molding - Scratch - Small / Trunk Hood, Rear Gate - Scratch & Dent - Small / Roof - Scratch & Dent - Small |
