## General Information

<b>Make</b>	Toyota	<b>Model</b>	Vios
<b>YOM</b>	2022	<b>Odo Meter Reading</b>	72,254
<b>Registration No.</b>	FAJ7548	<b>Chassis No.</b>	PA1B18F39N4184090
<b>CC</b>	1.3	<b>Transmission</b>	CVT
<b>Fuel Type</b>	Gas	<b>Type of Body</b>	Sedan
<b>Colour</b>	Silver

## Body / Panel Condition

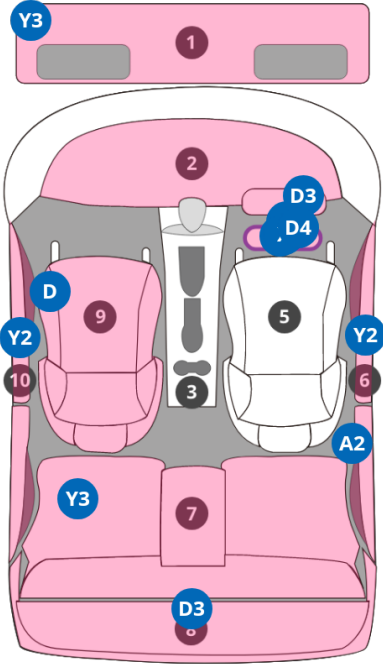
<b>Interior Evaluation :</b> <span style="float: right; color: red; font-weight: bold;">D</span>	<b>Exterior Evaluation :</b> <span style="float: right; color: red; font-weight: bold;">E</span>

<p><b>a</b> : Cut, Fray <b>d</b> : Loose, Deformed <b>k</b> : Animal Hair <b>s</b> : Smell <b>t</b> : Cigarette Burns <b>x</b> : Defective <b>y</b> : Stain</p>

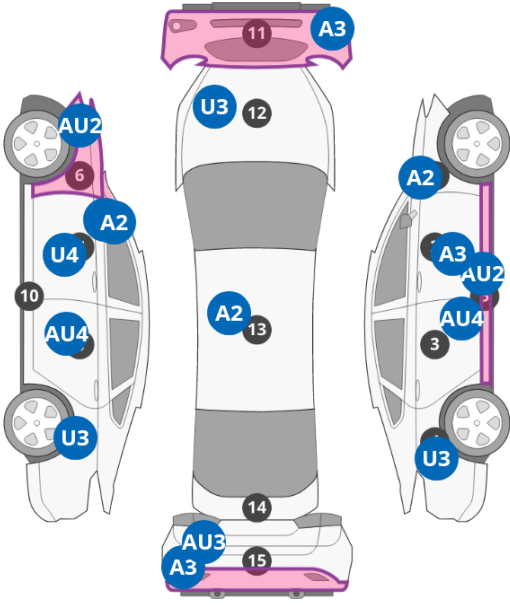
<p><b>A</b> : Scratch <b>AU</b> : Scratch &amp; Dent <b>B</b> : Modified <b>C</b> : Corrosion <b>G</b> : Stone chip <b>P</b> : Faded <b>S</b> : Rust <b>SC</b> : Rust &amp; Corrosion <b>U</b> : Dent <b>X</b> : Defective <b>Y</b> : Crack, Gap</p>
<p><b>Remarks</b> Rear Seat - Grime - Medium / (L) Front Seat - Worn - Yes / Ceiling - Grime - Medium / (R) Front Trim - Grime - Small / (L) Front Trim - Grime - Small / Mat Other - Missing - Yes / (R) Front Floor Mat - Missing - Yes / (L) Front Floor Mat - Missing - Yes / Trunk Room - Loose, Deformed - Medium / Glove Box - Loose, Deformed - Medium / (R) Rear Trim - Cut, Crack - Small / Carpet - Worked - Large</p>	<p><b>Remarks</b> Bonnet - Repair Traces - Yes / (L) Front Fender - Repair Traces - Yes / Trunk Hood, Rear Gate - Repair Traces - Yes / (R) Rear Fender - Repair Traces - Yes / (R) Front Fender, Molding - Scratch - Small / (R) Rear Door, Molding - Scratch &amp; Dent - Large / (R) Step, In-panel, Side Spoiler - Repair mark - Yes / (R) Step, In-panel, Side Spoiler - Scratch &amp; Dent - Small / (R) Front Door, Molding - Scratch - Medium / (R) Rear Fender, Molding - Dent - Medium / Rear Bumper, Lamps, Panels - Repair mark - Yes / Rear Bumper, Lamps, Panels - Scratch - Medium / Trunk Hood, Rear Gate - Scratch &amp; Dent - Medium / (L) Rear Fender, Molding - Dent - Medium / (L) Rear Door, Molding - Scratch &amp; Dent - Large / (L) Front Door, Molding - Dent - Large / (L) Mirror - Crack - Damaged / (L) Front Fender, Molding - Repair mark - Yes / Bonnet, Headlight - Dent - Medium / Front Bumper, Grille, Lamps - Repair mark - Yes / (L) Mirror - Scratch - Small / (L) Front Fender, Molding - Scratch &amp; Dent - Small / Front Bumper, Grille, Lamps - Scratch - Medium / Roof - Scratch - Small</p>
