## General Information

| Make | Toyota | Model | Vios |
| YOM | 2023 | Mileage | 7,537 |
| Registration No. | NHJ5694 | Chassis No. | PA1B18F35P4216259 |

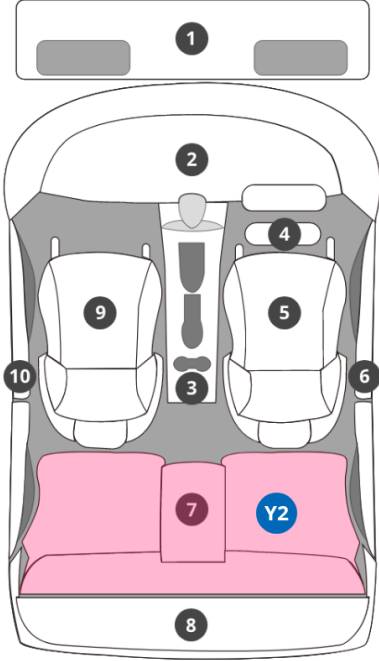
| Interior Evaluation : <span style="color: red;">A</span> | Exterior Evaluation : <span style="color: red;">E</span> |
|---|---|
| <b>Remarks</b><br>Rear Seat - Grime - Small | <b>Remarks</b><br>Bonnet, Headlight - Crack, Gap - Medium / (L) Front Fender, Molding - Scratch & Dent - Large / Front Bumper, Grille, Lamps - Scratch & Dent - Large / (L) Mirror - Crack - Damaged / (R) Front Fender, Molding - Dent - Small / (R) Front Door, Molding - Scratch - Small / (R) Rear Door, Molding - Scratch - Medium / Rear Bumper, Lamps, Panels - Scratch & Dent - Minimal / (L) Rear Fender, Molding - Scratch - Small / (L) Rear Door, Molding - Scratch - Medium / (L) Front Door, Molding - Scratch - Minimal |
