General Information

Make	Toyota	Model	Hilux
YOM	2024	Odo Meter Reading	78,568
Registration No.	FAQ4962	Chassis No.	MR0JB8DD4P3548474
CC	2.4	Transmission	M/T
Fuel Type	Diesel	Type of Body	Pickup
Colour	Black

Body / Panel Condition

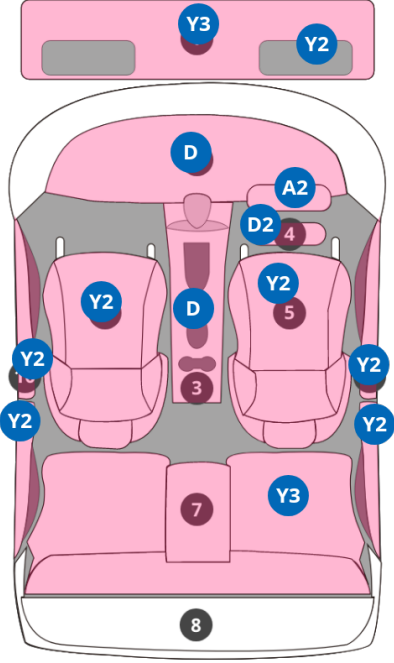
Interior Evaluation : C	Exterior Evaluation : C

<p>a : Cut, Fray d : Loose, Deformed k : Animal Hair s : Smell t : Cigarette Burns x : Defective y : Stain</p>

<p>A : Scratch AU : Scratch & Dent B : Modified C : Corrosion G : Stone chip P : Faded S : Rust SC : Rust & Corrosion U : Dent X : Defective Y : Crack, Gap</p>
<p>Remarks (L) Front Seat - Grime - Small / (L) Front Floor Mat - Worked - Small / (R) Front Seat - Grime - Small / Rear Seat - Grime - Medium / Ceiling - Grime - Medium / Sunvisor, Sunglass Holder - Grime - Small / Console, Switches, Vents - Traces of Adhesive Tape - Yes / Dashboard - Traces of Adhesive Tape - Yes / Steering Wheel - Worn, Peel, Crack - Small / (R) Front Trim - Grime - Small / (R) Rear Trim - Grime - Small / (L) Rear Trim - Grime - Small / (L) Front Trim - Grime - Small</p>	<p>Remarks (L) Side Gate - Scratch - Small / (L) Front Door, Molding - Scratch & Dent - Small / (L) Rear Door, Molding - Scratch - Minimal / (L) Front Fender, Molding - Scratch - Small / (L) Mirror - Scratch - Minimal / Front Bumper, Grille, Lamps - Modified - Medium / (R) Front Fender, Molding - Modified - Small / (R) Front Fender, Molding - Scratch - Small / Front Bumper, Grille, Lamps - Scratch - Small / (R) Mirror - Scratch - Minimal / (R) Front Door, Molding - Scratch - Small / (R) Rear Door, Molding - Scratch - Small / (R) Side Gate - Scratch - Small / Bonnet, Headlight - Dent - Small / Rear Bumper, Lamps, Panels - Scratch - Small</p>

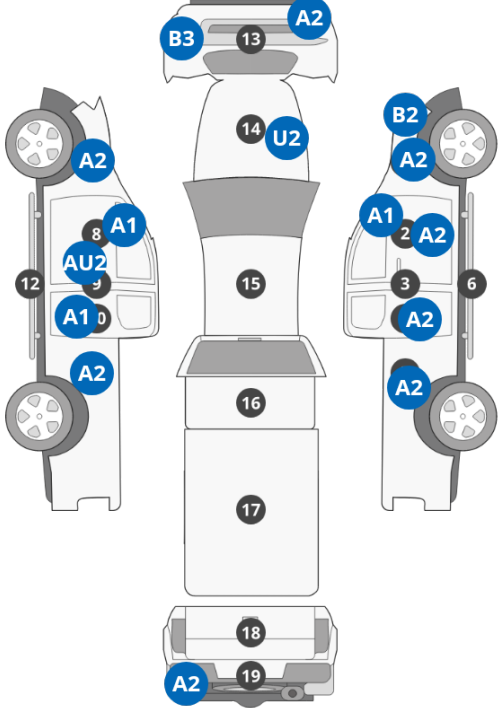
<p>Inspector Notes</p>
<p>Crack at front bumper. With warranty booklet and spare tire. Without jack, tools and seat cover. 1 key. With LTO plate.</p>
