General Information

Make	Toyota	Model	Vios
YOM	2025	Odo Meter Reading	23,973
Registration No.	FAQ9203	Chassis No.	PA1B18F36R4266879
CC	1.3	Transmission	CVT
Fuel Type	Gas	Type of Body	Sedan
Colour	Red

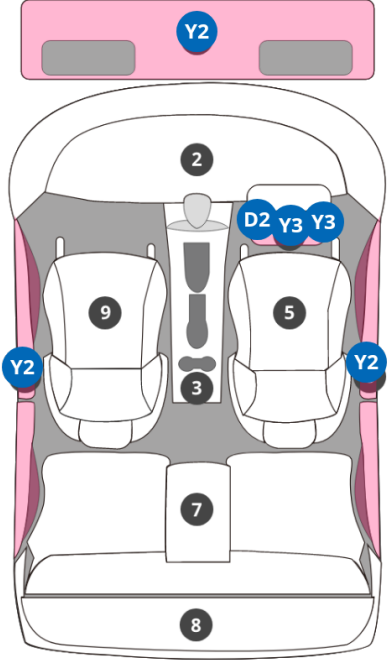
Interior Evaluation : B	Exterior Evaluation : B

<p>a : Cut, Fray d : Loose, Deformed k : Animal Hair s : Smell t : Cigarette Burns x : Defective y : Stain</p>

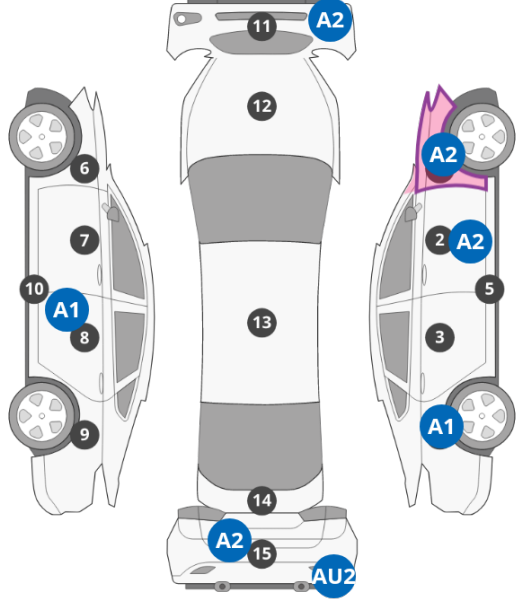
<p>A : Scratch AU : Scratch & Dent B : Modified C : Corrosion G : Stone chip P : Faded S : Rust SC : Rust & Corrosion U : Dent X : Defective Y : Crack, Gap</p>
<p>Remarks Ceiling - Grime - Small / (R) Front Floor Mat - Grime - Medium / (R) Front Trim - Grime - Small / Mat Other - Grime - Medium / (L) Front Floor Mat - Worked - Small / (L) Front Trim - Grime - Small</p>	<p>Remarks (R) Front Fender - Repair Traces - Yes / (L) Rear Door, Molding - Scratch - Minimal / Trunk Hood, Rear Gate - Scratch - Small / Rear Bumper, Lamps, Panels - Scratch & Dent - Small / (R) Rear Fender, Molding - Scratch - Minimal / (R) Front Door, Molding - Scratch - Small / (R) Front Fender, Molding - Scratch - Small / Front Bumper, Grille, Lamps - Scratch - Small / (R) Front Fender, Molding - Repair mark - Yes</p>
