## General Information

| Make | Toyota | Model | Innova |
| YOM | 2025 | Odo Meter Reading | 8,683 |
| Registration No. | FAQ9209 | Chassis No. | PA2JA8EM4R0146572 |

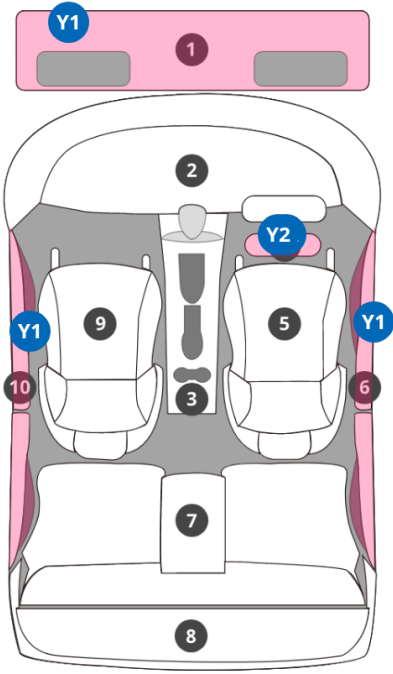
| Interior Evaluation : <b>A</b> | Exterior Evaluation : <b>B</b> |
|---|---|
| <p><b>Remarks</b><br/>(L) Front Trim - Grime - Minimal / (R) Front Trim - Grime - Minimal / Ceiling - Grime - Minimal / (L) Front Floor Mat - Worked - Small / (L) Front Floor Mat - Grime - Small</p> | <p><b>Remarks</b><br/>(R) Front Fender, Molding - Scratch - Small / (R) Mirror - Scratch - Minimal / (R) Front Door, Molding - Scratch - Small / (R) Rear Door, Molding - Scratch - Minimal / (R) Rear Fender, Molding - Scratch - Minimal / Rear Bumper, Lamps, Panels - Scratch - Small / Trunk Hood, Rear Gate - Scratch - Small / (L) Rear Fender, Molding - Scratch - Minimal / (L) Rear Door, Molding - Scratch - Minimal / (L) Front Door, Molding - Scratch - Small / (L) Mirror - Scratch - Minimal / (L) Front Fender, Molding - Scratch - Minimal / Front Bumper, Grille, Lamps - Scratch - Minimal / Bonnet, Headlight - Scratch - Minimal / Roof - Scratch - Minimal</p> |

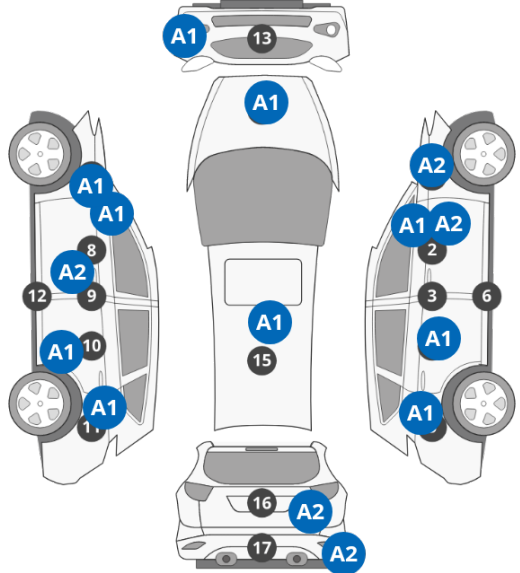
| Inspector Notes |
|---|
| no warranty booklet, with jack and tools, with spare tire, with LTO plate, scratch on tail light and headlight and |
