General Information

Make	Toyota	Model	Wigo
YOM	2024	Odo Meter Reading	32,346
Registration No.	FAR7039	Chassis No.	MHKAA1BC8RJ018595
CC	1.0	Transmission	CVT
Fuel Type	Gas	Type of Body	Hatchback
Colour	Gray

Body / Panel Condition

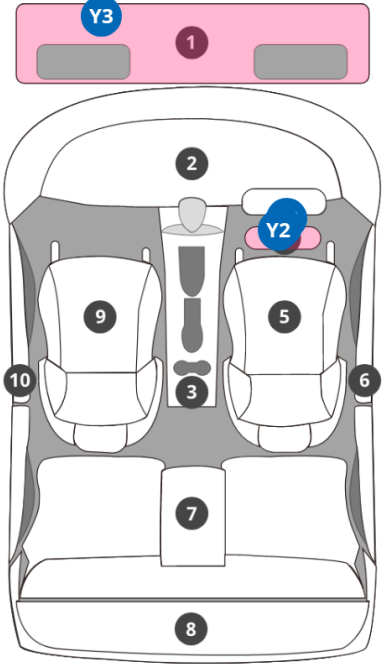
Interior Evaluation : B	Exterior Evaluation : C

<p>a : Cut, Fray d : Loose, Deformed k : Animal Hair s : Smell t : Cigarette Burns x : Defective y : Stain</p>

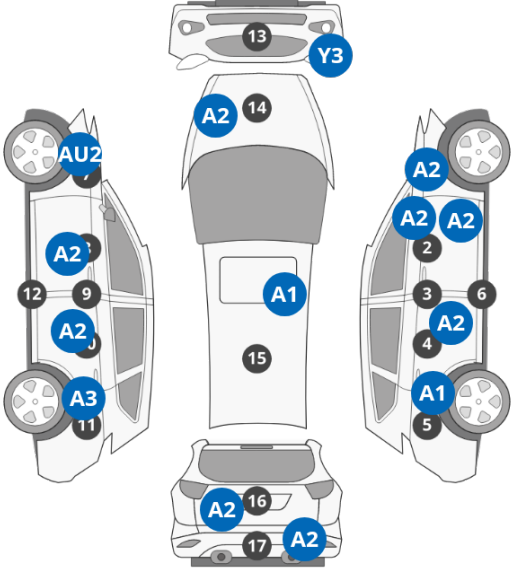
<p>A : Scratch AU : Scratch & Dent B : Modified C : Corrosion G : Stone chip P : Faded S : Rust SC : Rust & Corrosion U : Dent X : Defective Y : Crack, Gap</p>
<p>Remarks Mat Other - Grime - Small / (R) Front Floor Mat - Grime - Small / (L) Front Floor Mat - Grime - Small / Ceiling - Grime - Medium</p>	<p>Remarks (R) Front Fender, Molding - Scratch - Small / (R) Mirror - Scratch - Small / (R) Front Door, Molding - Scratch - Small / (R) Rear Door, Molding - Scratch - Small / (R) Rear Fender, Molding - Scratch - Minimal / Rear Bumper, Lamps, Panels - Scratch - Small / Trunk Hood, Rear Gate - Scratch - Small / (L) Rear Fender, Molding - Scratch - Medium / (L) Front Door, Molding - Scratch - Small / (L) Rear Door, Molding - Scratch - Small / (L) Front Fender, Molding - Scratch & Dent - Small / Front Bumper, Grille, Lamps - Crack, Gap - Medium / Bonnet, Headlight - Scratch - Small / Roof - Scratch - Minimal</p>
