## General Information

| Make | Toyota | Model | Vios |
| Registration No. | FAR8285 | Chassis No. | PA1B18F31R4255210 |

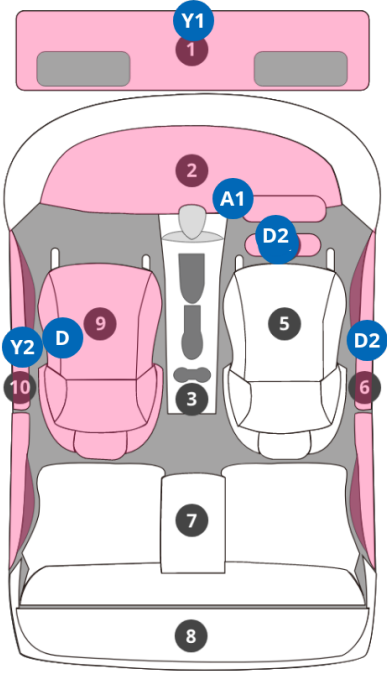
| Interior Evaluation : <b>B</b> | Exterior Evaluation : <b>E</b> |
|---|---|
| <p><b>Remarks</b></p> <p>Ceiling - Grime - Minimal / (R) Front Trim - Worked - Small / (L) Front Trim - Grime - Small / (L) Front Seat - Worn - Yes / (R) Front Floor Mat - Worked - Small / (L) Front Floor Mat - Worked - Small / Dashboard - Worn, Scratch, Cut, Crack - Minimal</p> | <p><b>Remarks</b></p> <p>(L) Front Door - Repair Traces - Yes / (R) Front Fender, Molding - Scratch - Medium / (R) Mirror - Scratch - Small / (R) Step, In-panel, Side Spoiler - Scratch - Small / (R) Front Door, Molding - Scratch - Small / (R) Rear Door, Molding - Scratch - Small / (R) Rear Fender, Molding - Scratch - Small / Rear Bumper, Lamps, Panels - Scratch - Small / Trunk Hood, Rear Gate - Scratch - Small / (L) Rear Fender, Molding - Scratch - Small / (L) Rear Door, Molding - Scratch - Small / (L) Front Door, Molding - Scratch - Minimal / (L) Mirror - Scratch - Small / (L) Front Fender, Molding - Scratch - Minimal / Member (Bolted) - Dent - Yes / Front Bumper, Grille, Lamps - Scratch - Small / Bonnet, Headlight - Scratch - Medium / Front Windshield - Damaged - Large / Roof - Scratch - Minimal</p> |
