## General Information

| Make | Toyota | Model | Vios |
| Registration No. | FAS5512 | Chassis No. | PA1B18F34R4280540 |

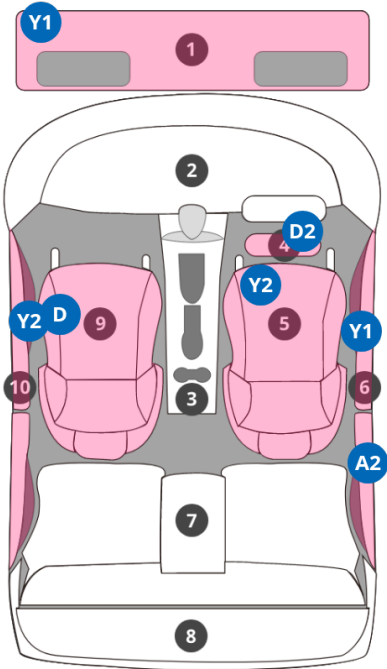
| Interior Evaluation : <span style="color: red;">B</span> | Exterior Evaluation : <span style="color: red;">B</span> |
| <b>Remarks</b><br>(L) Front Seat - Worn - Yes / (R) Front Seat - Grime - Small / (L) Front Floor Mat - Worked - Small / (R) Front Trim - Grime - Minimal / (L) Front Trim - Grime - Small / Ceiling - Grime - Minimal / (R) Rear Trim - Cut, Crack - Small | <b>Remarks</b><br>(R) Front Fender, Molding - Scratch - Minimal / (R) Mirror - Scratch - Minimal / (R) Front Door, Molding - Scratch - Small / (R) Step, In-panel, Side Spoiler - Scratch & Dent - Medium / (R) Rear Door, Molding - Scratch - Small / (R) Rear Fender, Molding - Scratch - Minimal / Rear Bumper, Lamps, Panels - Scratch - Minimal / Trunk Hood, Rear Gate - Scratch - Small / (L) Rear Fender, Molding - Scratch - Minimal / (L) Rear Door, Molding - Scratch - Minimal / (L) Front Door, Molding - Scratch - Minimal / (L) Front Fender, Molding - Scratch - Small / Member (Bolted) - Dent - Yes / Front Bumper, Grille, Lamps - Scratch - Minimal / Bonnet, Headlight - Scratch - Minimal |

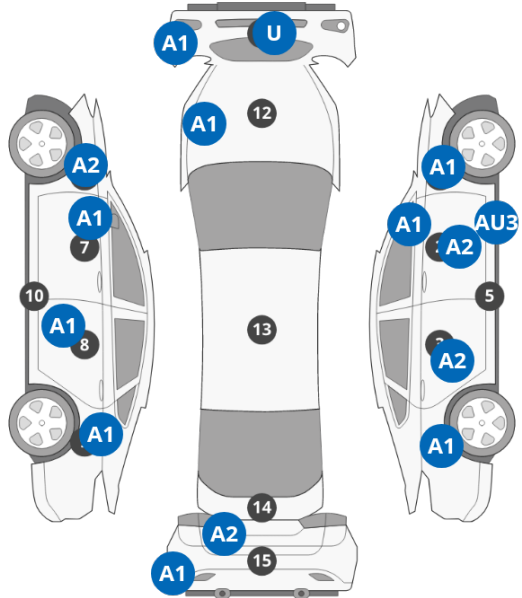
no warranty booklet, with jack and tools, with spare tire, with LTO plate, scratches on tail light
