General Information

Make	Toyota	Model	Vios
YOM	2025	Odo Meter Reading	35,327
Registration No.	FAS8055	Chassis No.	PA1B18F38S4282507
CC	1.3	Transmission	CVT
Fuel Type	Gas	Type of Body	Sedan
Colour	Silver

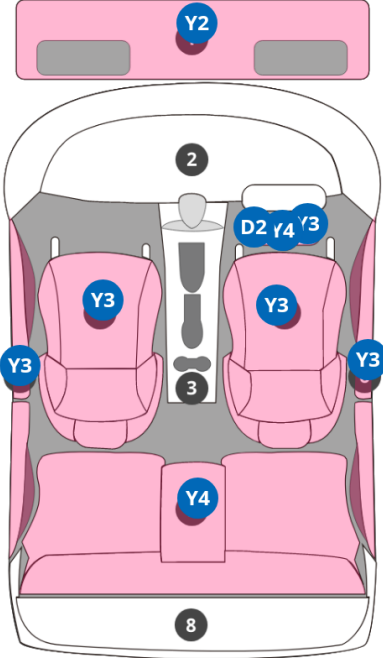
Interior Evaluation : D	Exterior Evaluation : B

<p>a : Cut, Fray d : Loose, Deformed k : Animal Hair s : Smell t : Cigarette Burns x : Defective y : Stain</p>

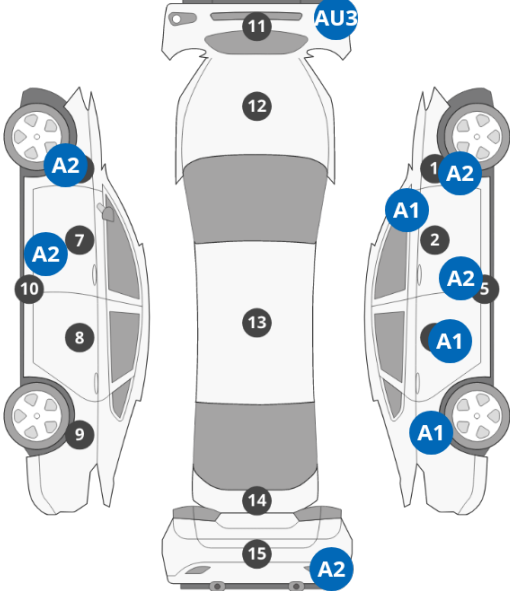
<p>A : Scratch AU : Scratch & Dent B : Modified C : Corrosion G : Stone chip P : Faded S : Rust SC : Rust & Corrosion U : Dent X : Defective Y : Crack, Gap</p>
<p>Remarks Ceiling - Grime - Small / (R) Front Seat - Grime - Medium / (R) Front Floor Mat - Grime - Medium / (R) Front Trim - Grime - Medium / Rear Seat - Grime - Large / Mat Other - Grime - Large / (L) Front Trim - Grime - Medium / (L) Front Seat - Grime - Medium / (L) Front Floor Mat - Worked - Small</p>	<p>Remarks (R) Front Fender, Molding - Scratch - Small / (R) Mirror - Scratch - Minimal / (R) Rear Door, Molding - Scratch - Minimal / (R) Front Door, Molding - Scratch - Small / (R) Rear Fender, Molding - Scratch - Minimal / Rear Bumper, Lamps, Panels - Scratch - Small / (L) Front Door, Molding - Scratch - Small / (L) Front Fender, Molding - Scratch - Small / Front Bumper, Grille, Lamps - Scratch & Dent - Medium</p>
