## General Information

| Make | Toyota | Model | Wigo |
| Registration No. | FAS8646 | Chassis No. | MHKAA1BC5SJ034484 |

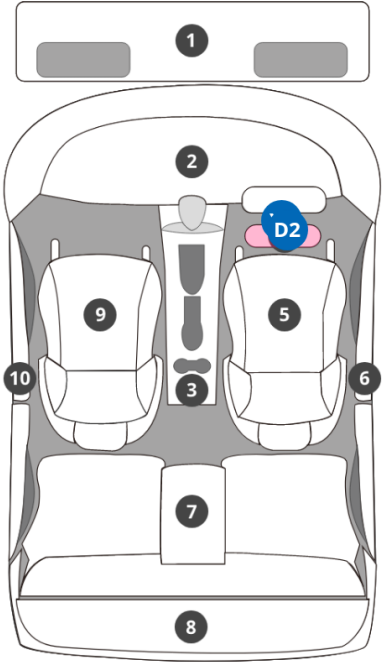
| Interior Evaluation : <b>A</b> | Exterior Evaluation : <b>C</b> |
| <b>Remarks</b><br>Mat Other - Grime - Small / (L) Front Floor Mat - Worked - Small | <b>Remarks</b><br>(R) Front Fender, Molding - Scratch - Small / (R) Front Door, Molding - Scratch - Minimal / (R) Rear Door, Molding - Scratch - Small / (R) Rear Fender, Molding - Scratch - Minimal / Trunk Hood, Rear Gate - Scratch - Minimal / Rear Bumper, Lamps, Panels - Scratch - Small / (L) Rear Fender, Molding - Scratch - Minimal / (L) Rear Door, Molding - Scratch - Minimal / (L) Front Door, Molding - Scratch - Small / (L) Mirror - Scratch - Minimal / (L) Front Fender, Molding - Scratch - Minimal / Front Bumper, Grille, Lamps - Scratch - Small / Bonnet, Headlight - Scratch - Small / Roof - Scratch - Small |

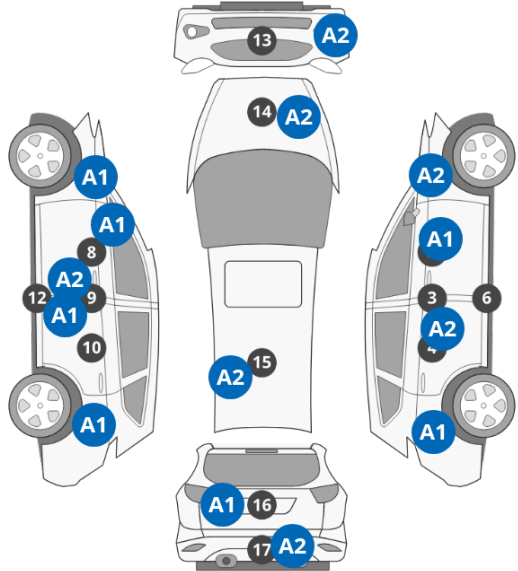
with warranty booklet, no jack and tools, with spare tire, with LTO plate, scratches on tail light
