## General Information

| Make | Toyota | Model | Vios |
| Registration No. | FAQ9295 | Chassis No. | PA1B18F36R4269541 |

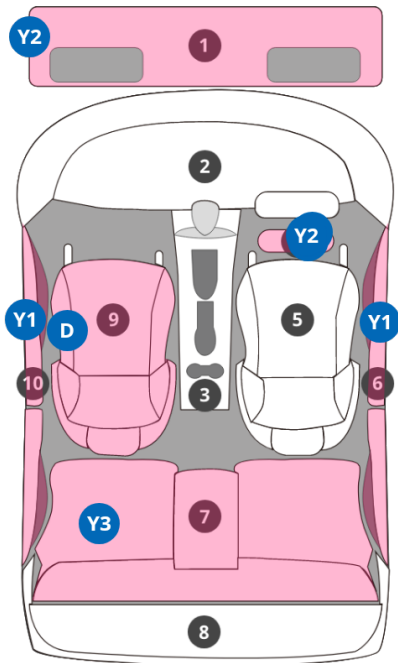
| Interior Evaluation : <b>B</b> | Exterior Evaluation : <b>E</b> |
| <p><b>Remarks</b><br/>(L) Front Floor Mat - Worked - Small / (R) Front Trim - Grime - Minimal / (L) Front Trim - Grime - Minimal / (R) Front Floor Mat - Grime - Small / (L) Front Seat - Worn - Yes / Rear Seat - Grime - Medium / Ceiling - Grime - Small / Mat Other - Grime - Small</p> | <p><b>Remarks</b><br/>(R) Front Fender, Molding - Scratch - Minimal / (R) Rear Door, Molding - Scratch - Large / (R) Front Door, Molding - Scratch - Small / (R) Rear Fender, Molding - Scratch - Small / (R) Mirror - Scratch - Minimal / Rear Bumper, Lamps, Panels - Scratch &amp; Dent - Large / Trunk Hood, Rear Gate - Scratch - Small / (L) Rear Fender, Molding - Dent - Medium / (L) Rear Door, Molding - Scratch - Small / (L) Step, In-panel, Side Spoiler - Scratch &amp; Dent - Large / (L) Front Door, Molding - Dent - Small / (L) Front Fender, Molding - Dent - Large / (L) Mirror - Scratch - Small / Bonnet, Headlight - Scratch &amp; Dent - Medium / Member (Bolted) - Dent - Yes / Front Bumper, Grille, Lamps - Scratch &amp; Dent - Small / Roof - Scratch - Small</p> |

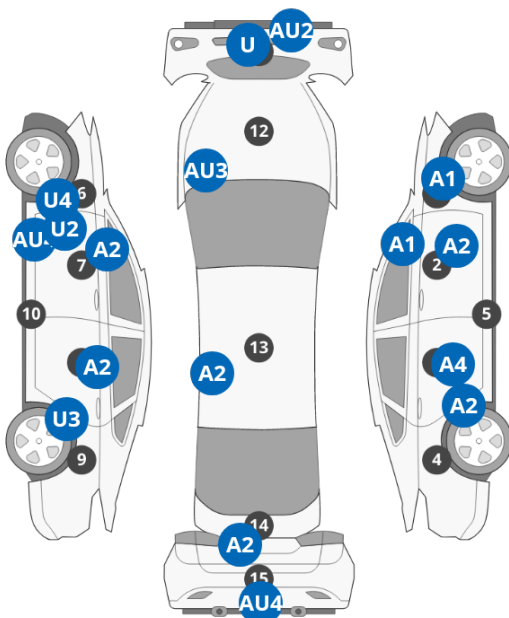
| Inspector Notes |
|---|
| with warranty booklet, with jack and tools, with spare tire, with LTO plate, scratches on tail light, cheek light loose |
