## General Information

| Make | Toyota | Model | Veloz |

## Body / Panel Condition

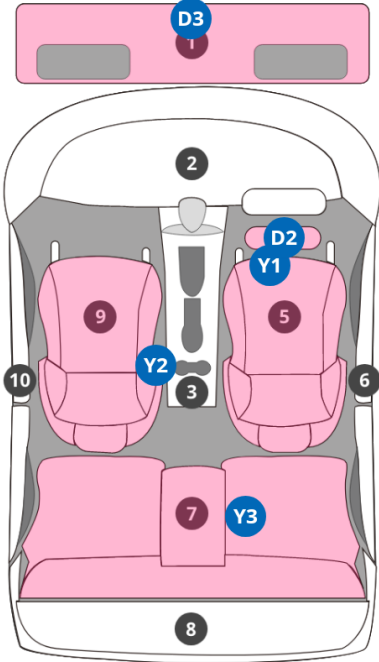
| Interior Evaluation : <b>B</b> | Exterior Evaluation : <b>C</b> |
|---|---|
| <b>Remarks</b><br>(L) Front Seat - Grime - Small / (R) Front Seat - Grime - Minimal / Rear Seat - Grime - Medium / (L) Front Floor Mat - Worked - Small / Ceiling - Crinkle - Medium | <b>Remarks</b><br>(R) Front Fender, Molding - Scratch - Minimal / (R) Step, In-panel, Side Spoiler - Scratch & Dent - Medium / (R) Front Door, Molding - Scratch - Small / (R) Mirror - Scratch - Minimal / (R) Rear Door, Molding - Scratch & Dent - Medium / (R) Rear Fender, Molding - Scratch & Dent - Small / Rear Bumper, Lamps, Panels - Scratch - Small / Trunk Hood, Rear Gate - Scratch - Minimal / (L) Rear Fender, Molding - Scratch - Minimal / (L) Rear Door, Molding - Scratch - Small / (L) Front Door, Molding - Scratch - Minimal / (L) Mirror - Scratch - Minimal / (L) Front Fender, Molding - Scratch - Minimal / Front Bumper, Grille, Lamps - Scratch - Small / Bonnet, Headlight - Scratch & Dent - Small / Roof - Scratch - Small |

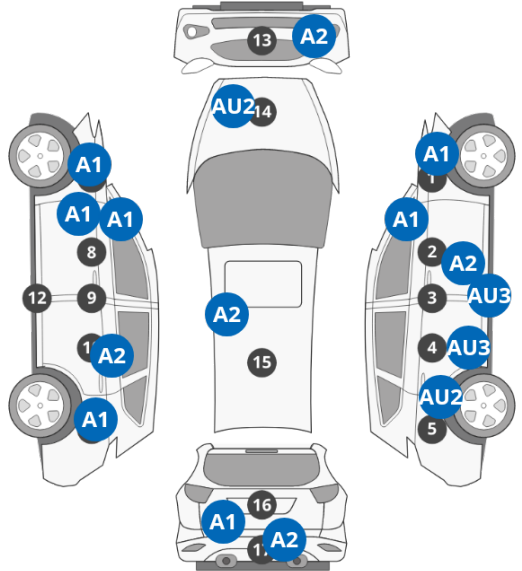
| Inspector Notes |
|---|
| with warranty booklet, no jack and tools, with spare tire, with LTO plate, scratches on tail light, dome light issue |
