General Information

Make	Toyota	Model	Wigo
YOM	2025	Odo Meter Reading	8,751
Registration No.	GBK1332	Chassis No.	MHKAA1BC7SJ037922
CC	1.0	Transmission	CVT
Fuel Type	Gas	Type of Body	Hatchback
Colour	Orange

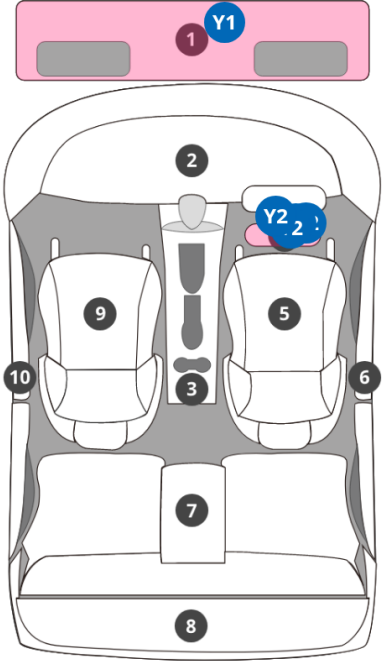
Interior Evaluation : B	Exterior Evaluation : B

<p>a : Cut, Fray d : Loose, Deformed k : Animal Hair s : Smell t : Cigarette Burns x : Defective y : Stain</p>

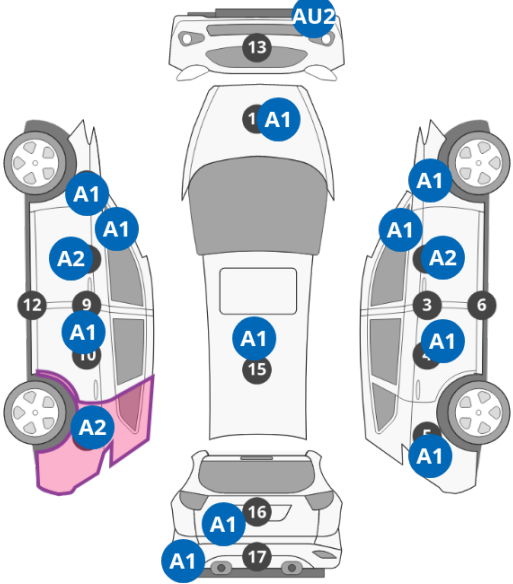
<p>A : Scratch AU : Scratch & Dent B : Modified C : Corrosion G : Stone chip P : Faded S : Rust SC : Rust & Corrosion U : Dent X : Defective Y : Crack, Gap</p>
<p>Remarks (L) Front Floor Mat - Worked - Small / (L) Front Floor Mat - Grime - Small / Mat Other - Grime - Small / (R) Front Floor Mat - Grime - Small / Ceiling - Grime - Minimal</p>	<p>Remarks (R) Front Fender, Molding - Scratch - Minimal / (R) Mirror - Scratch - Minimal / (R) Front Door, Molding - Scratch - Small / (R) Rear Door, Molding - Scratch - Minimal / (R) Rear Fender, Molding - Scratch - Minimal / Rear Bumper, Lamps, Panels - Scratch - Minimal / Trunk Hood, Rear Gate - Scratch - Minimal / (L) Rear Fender, Molding - Repair mark - Yes / (L) Rear Fender, Molding - Scratch - Small / (L) Rear Door, Molding - Scratch - Minimal / (L) Front Door, Molding - Scratch - Small / (L) Mirror - Scratch - Minimal / (L) Front Fender, Molding - Scratch - Minimal / Front Bumper, Grille, Lamps - Scratch & Dent - Small / Bonnet, Headlight - Scratch - Minimal / Roof - Scratch - Minimal</p>

<p>Inspector Notes</p>
<p>with warranty booklet, with jack, no tools, with spare tire, with LTO plate, scratches on tail light</p>
