## General Information

| Make | Toyota | Model | Vios |
| YOM | 2021 | Odo Meter Reading | 127,214 |
| Registration No. | NET2203 | Chassis No. | PA1B18F34M4150881 |

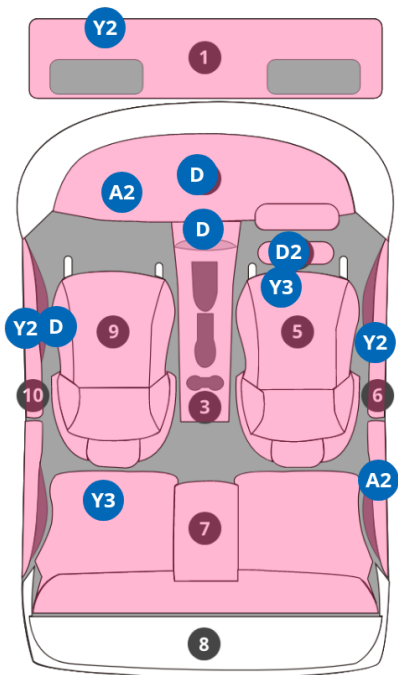
| Interior Evaluation : <b>C</b> | Exterior Evaluation : <b>E</b> |
|---|---|
| <b>Remarks</b><br>(R) Front Seat - Grime - Medium / (L) Front Seat - Worn - Yes / (L) Front Trim - Grime - Small / (R) Front Trim - Grime - Small / (L) Front Floor Mat - Worked - Small / Ceiling - Grime - Small / Rear Seat - Grime - Medium / (R) Rear Trim - Cut, Crack - Small / Console, Switches, Vents - Traces of Adhesive Tape - Yes / Dashboard - Traces of Adhesive Tape - Yes / Dashboard - Worn, Scratch, Cut, Crack - Small | <b>Remarks</b><br>Bonnet - Repair Traces - Yes / (R) Front Fender, Molding - Scratch - Small / (R) Mirror - Scratch - Small / (R) Front Door, Molding - Scratch - Small / (R) Step, In-panel, Side Spoiler - Scratch & Dent - Medium / (R) Rear Door, Molding - Scratch - Large / (R) Rear Fender, Molding - Scratch & Dent - Small / Rear Bumper, Lamps, Panels - Scratch & Dent - Small / Trunk Hood, Rear Gate - Scratch - Small / (L) Rear Fender, Molding - Scratch - Small / (L) Rear Door, Molding - Scratch - Medium / (L) Front Door, Molding - Scratch - Small / (L) Mirror - Crack - Damaged / (L) Mirror - Scratch - Small / Bonnet, Headlight - Crack, Gap - Medium / (L) Front Fender, Molding - Scratch - Minimal / Member (Bolted) - Dent - Yes / Front Bumper, Grille, Lamps - Scratch - Medium / Roof - Dent - Small |

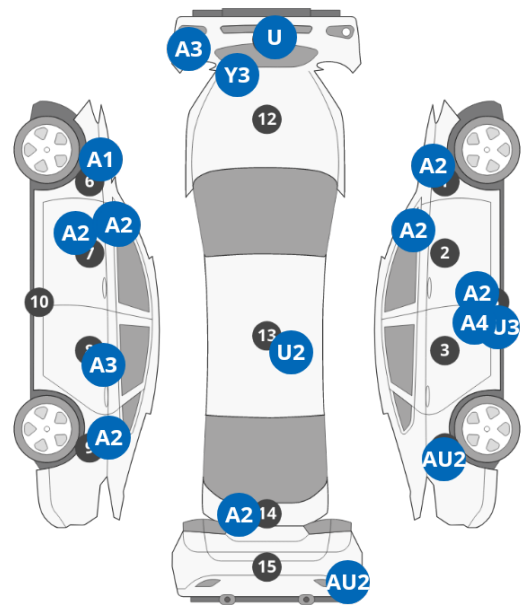
| Inspector Notes |
|---|
| with warranty booklet, with jack, incomplete tools, with spare tire, with LTO plate, possible flooding, scratches on tail light, left side mirror loose |
