## General Information

| Make | Suzuki | Model | Ertiga |

## Body / Panel Condition

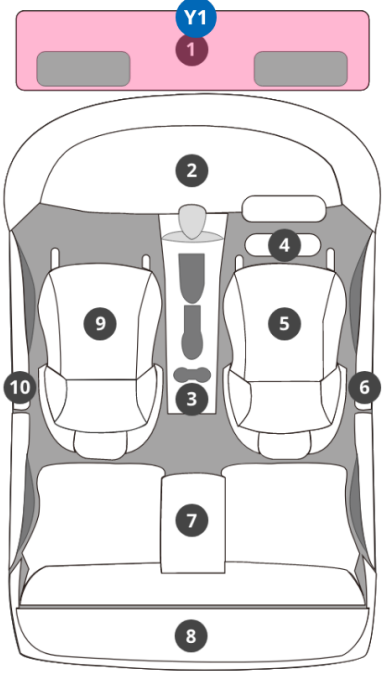
| <b>Interior Evaluation :</b> <span style="color: red; font-weight: bold;">A</span> | <b>Exterior Evaluation :</b> <span style="color: red; font-weight: bold;">C</span> |
| <b>Remarks</b><br>Ceiling - Grime - Minimal | <b>Remarks</b><br>(R) Rear Door, Molding - Scratch & Dent - Minimal / (R) Front Door, Molding - Scratch & Dent - Small / (R) Step, In-panel, Side Spoiler - Scratch & Dent - Minimal / (R) Front Fender, Molding - Scratch - Small / Front Bumper, Grille, Lamps - Scratch - Small / Member (Bolted) - Dent - Yes / Bonnet, Headlight - Scratch & Dent - Small / Roof - Scratch & Dent - Small / (R) Mirror - Scratch - Minimal / (L) Front Fender, Molding - Scratch - Minimal / (L) Front Door, Molding - Scratch & Dent - Minimal / (L) Mirror - Scratch - Minimal / (L) Rear Door, Molding - Repair mark - Yes / (L) Rear Door, Molding - Scratch & Dent - Small / (L) Rear Fender, Molding - Scratch - Small / Trunk Hood, Rear Gate - Scratch & Dent - Small / Rear Bumper, Lamps, Panels - Scratch - Small / (R) Rear Fender, Molding - Scratch - Small / (L) Step, In-panel, Side Spoiler - Scratch & Dent - Small |

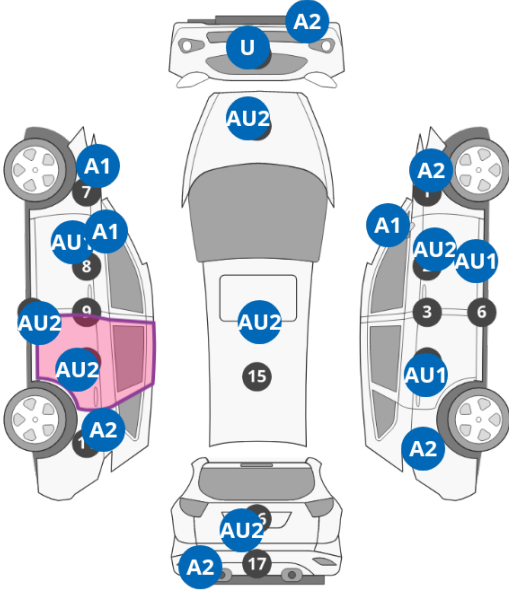
| With LTO plate and Sparetire, No warranty booklet and Tools and Jack, Scratch headlight and tail light, no reverse camera. |
