## General Information

| Make | Toyota | Model | Hilux Tamaraw |
| Registration No. | CCG7928 | Chassis No. | PAHACACA1S6421088 |

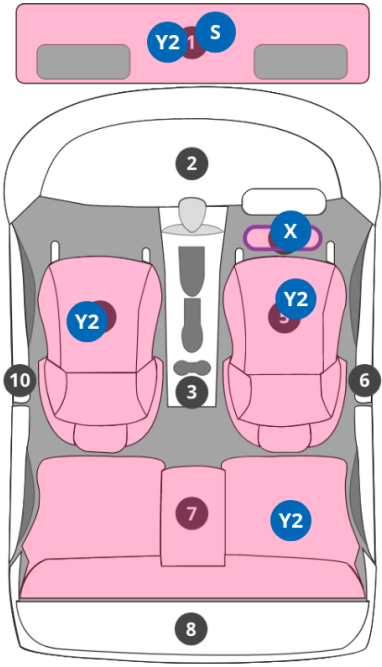
| Interior Evaluation : <b>B</b> | Exterior Evaluation : <b>C</b> |
|---|---|
| <p><b>Remarks</b></p> <p>Overall Interior - Smell - Yes / Mat Other - Missing - Yes / (L) Front Seat - Grime - Small / (R) Front Seat - Grime - Small / Rear Seat - Grime - Small / Ceiling - Grime - Small</p> | <p><b>Remarks</b></p> <p>Member (Bolted) - Dent - Yes / Front Bumper, Grille, Lamps - Scratch - Large / (R) Front Fender, Molding - Scratch - Minimal / (R) Front Door, Molding - Scratch &amp; Dent - Minimal / (R) Side Gate - Scratch &amp; Dent - Small / Rear Gate - Scratch &amp; Dent - Small / Rear Bumper, Lamps, Panels - Scratch - Medium / (L) Side Gate - Scratch &amp; Dent - Small / (L) Front Door, Molding - Scratch &amp; Dent - Small / (L) Front Fender, Molding - Scratch - Minimal / (L) Mirror - Scratch - Minimal / (R) Mirror - Scratch - Minimal / Bonnet, Headlight - Scratch - Small / Roof - Scratch - Small</p> |
