## General Information

| Make | Suzuki | Model | Carry |

## Body / Panel Condition

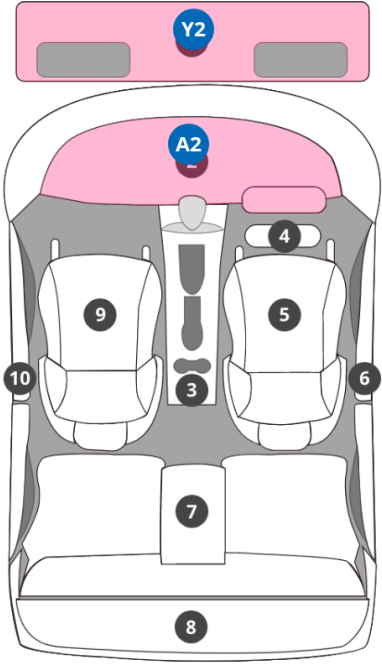
| Interior Evaluation : <b>A</b> | Exterior Evaluation : <b>A</b> |
|---|---|
| <b>Remarks</b><br>Ceiling - Grime - Small / Glove Box - Worn, Scratch, Cut, Crack - Small | <b>Remarks</b><br>(R) Side Gate - Scratch & Dent - Small / Rear Bumper, Lamps, Panels - Scratch - Minimal / (L) Side Gate - Scratch - Small / (L) Front Door, Molding - Scratch - Minimal |
