## General Information

| Make | Toyota | Model | Rush |

## Body / Panel Condition

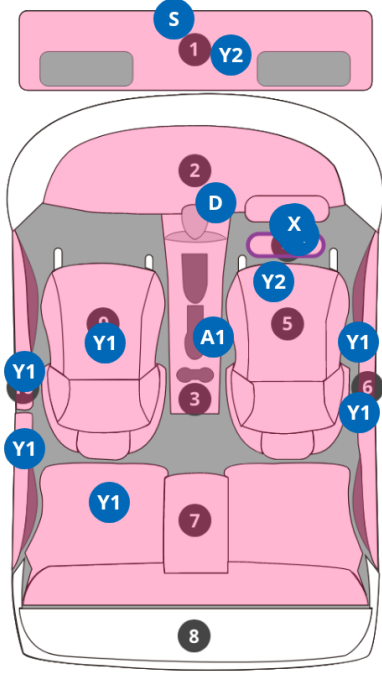
| Interior Evaluation : <b>B</b> | Exterior Evaluation : <b>E</b> |
| <b>Remarks</b><br>(R) Front Floor Mat - Missing - Yes / (L) Front Floor Mat - Missing - Yes / Mat Other - Missing - Yes / Ceiling - Grime - Small / Overall Interior - Smell - Yes / Dashboard - Traces of Adhesive Tape - Yes / (L) Front Trim - Grime - Minimal / (L) Rear Trim - Grime - Minimal / (R) Front Trim - Grime - Minimal / (R) Rear Trim - Grime - Minimal / (L) Front Seat - Grime - Minimal / (R) Front Seat - Grime - Small / Rear Seat - Grime - Minimal / Console, Switches, Vents - Worn, Scratch, Cut, Crack - Minimal | <b>Remarks</b><br>(R) Rear Door, Molding - Scratch & Dent - Large / Member (Bolted) - Dent - Yes / Rear Bumper, Lamps, Panels - Scratch - Medium / (R) Rear Fender, Molding - Scratch - Minimal / Trunk Hood, Rear Gate - Scratch & Dent - Small / (L) Rear Fender, Molding - Scratch - Minimal / (L) Rear Door, Molding - Scratch - Small / (L) Front Door, Molding - Scratch & Dent - Small / (L) Step, In-panel, Side Spoiler - Scratch - Small / (L) Mirror - Scratch - Minimal / Bonnet, Headlight - Scratch & Dent - Small / Front Bumper, Grille, Lamps - Crack, Gap - Large / (R) Front Fender, Molding - Scratch & Dent - Small / (R) Front Door, Molding - Scratch & Dent - Small / (R) Step, In-panel, Side Spoiler - Scratch - Small / (R) Mirror - Scratch - Minimal / Roof - Scratch & Dent - Small / (L) Front Fender, Molding - Scratch - Minimal |

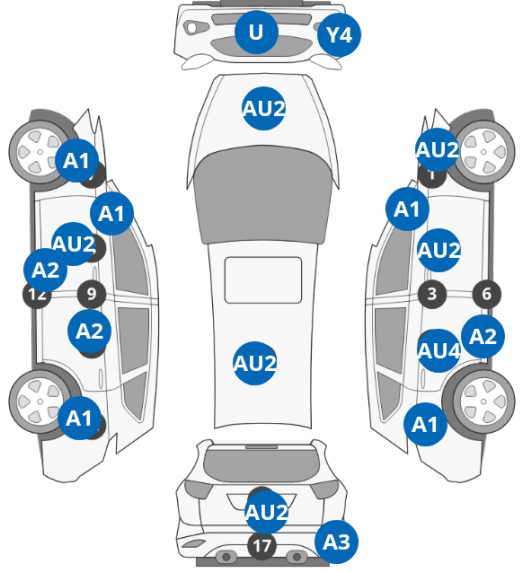
| Inspector Notes |
|---|
| With LTO plate and Sparetire, No Tools and Jack and Warranty booklet, scratch headlight and tail light, Worn Tires and Sparetire, No spare key, Abnormal vibration on engine, plate light issue, headlight issue. |
