## General Information

| Make | Toyota | Model | Vios |
| Registration No. | CCR4045 | Chassis No. | PA1B18F34S4289535 |

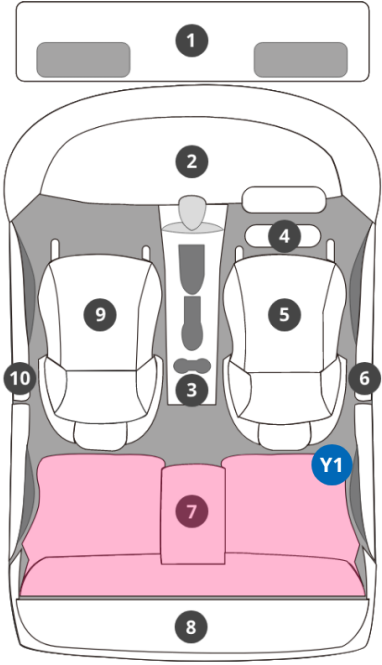
| Interior Evaluation : <span style="color: red; font-weight: bold;">A</span> | Exterior Evaluation : <span style="color: red; font-weight: bold;">A</span> |
|---|---|
| <b>Remarks</b><br>Rear Seat - Grime - Minimal | <b>Remarks</b><br>(R) Mirror - Scratch - Minimal / (R) Front Door, Molding - Scratch - Minimal / (R) Rear Door, Molding - Scratch - Small / (R) Rear Fender, Molding - Scratch - Minimal / Rear Bumper, Lamps, Panels - Scratch - Minimal / (L) Rear Fender, Molding - Scratch - Minimal / (L) Front Door, Molding - Scratch - Small / Front Bumper, Grille, Lamps - Scratch - Minimal |

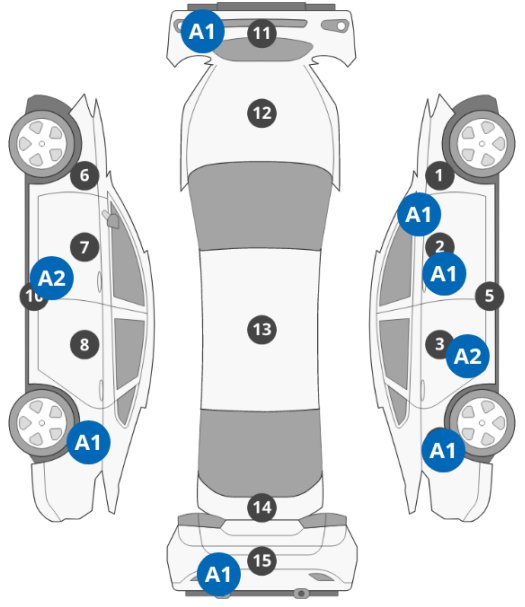
| Inspector Notes |
|---|
| With Lto plate, with jack and tools, 2 keys, No spare tire, scratches headlight |
