## General Information

| Make | Toyota | Model | Rush |

## Overall Evaluation :

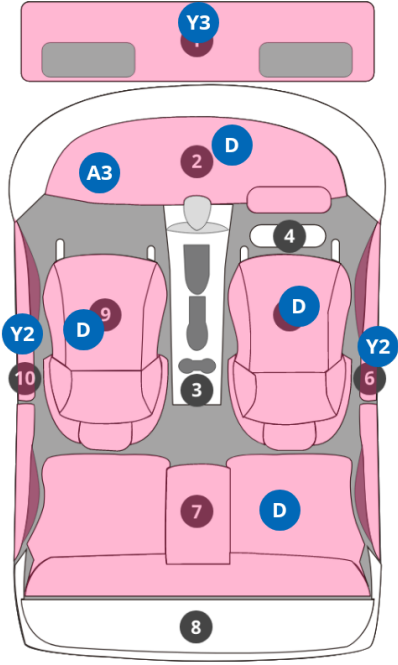
| Interior Evaluation : <b>C</b> | Exterior Evaluation : <b>E</b> |
|---|---|
| <p><b>Remarks</b></p> <p>(L) Front Seat - Worn - Yes / (R) Front Seat - Worn - Yes / Ceiling - Grime - Medium / Dashboard - Traces of Adhesive Tape - Yes / Steering Wheel - Worn, Peel, Crack - Medium / (L) Front Trim - Grime - Small / (R) Front Trim - Grime - Small / Rear Seat - Worn - Yes</p> | <p><b>Remarks</b></p> <p>(R) Front Fender - Repair Traces - Yes / Bonnet - Repair Traces - Yes / (L) Front Fender - Repair Traces - Yes / Trunk Hood, Rear Gate - Repair Traces - Yes / Bonnet, Headlight - Repair mark - Yes / (L) Front Fender, Molding - Repair mark - Yes / (R) Front Fender, Molding - Repair mark - Yes / Member (Bolted) - Dent - Yes / Front Bumper, Grille, Lamps - Crack, Gap - Medium / Bonnet, Headlight - Scratch &amp; Dent - Small / (L) Front Fender, Molding - Scratch - Minimal / (L) Front Door, Molding - Scratch &amp; Dent - Small / (L) Rear Door, Molding - Scratch &amp; Dent - Minimal / (L) Mirror - Scratch - Minimal / Rear Bumper, Lamps, Panels - Scratch - Medium / (L) Rear Fender, Molding - Scratch - Medium / Trunk Hood, Rear Gate - Scratch &amp; Dent - Small / (R) Rear Fender, Molding - Scratch - Small / (R) Rear Door, Molding - Scratch &amp; Dent - Small / (R) Front Door, Molding - Scratch - Minimal / (R) Mirror - Scratch - Minimal / (R) Front Fender, Molding - Scratch &amp; Dent - Small / (R) Step, In-panel, Side Spoiler - Scratch - Small / (L) Step, In-panel, Side Spoiler - Scratch - Minimal / Roof - Scratch &amp; Dent - Small</p> |

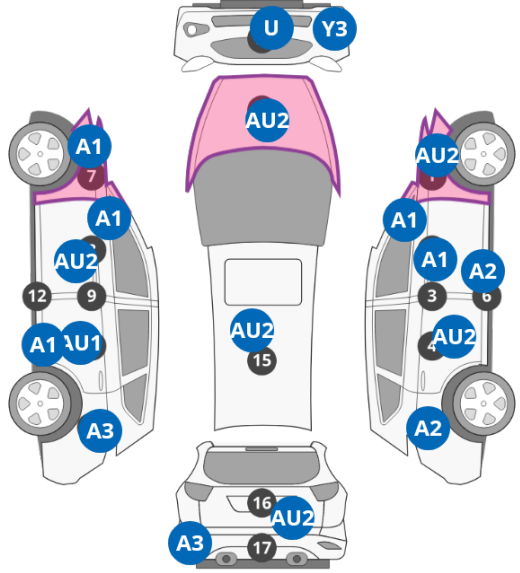
| Inspector Notes |
|---|
| <p>With LTO plate and Spare tire, No Tools and Jack and Warranty booklet, No spare key, worn tires, adhesive marks on vehicle, busted foglight, scratch headlight and tail light, foul smell, possible flooded, plate light issue and headlight bulb issue and room light issue.</p> |
