## General Information

| Make | Toyota | Model | Wigo |

## Body / Panel Condition

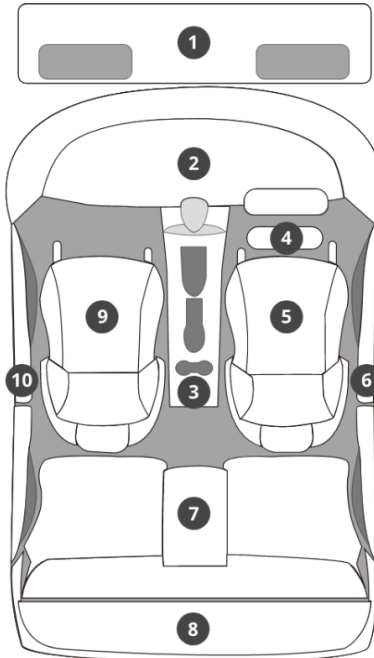
| <div> <div>Remarks</div> <div>Defects not found</div> </div> | <div> <div>Remarks</div> <div> Front Bumper, Grille, Lamps - Scratch - Medium / (L) Front Fender, Molding - Scratch - Minimal / (L) Front Door, Molding - Dent - Minimal / (L) Step, In-panel, Side Spoiler - Scratch &amp; Dent - Small / (L) Rear Door, Molding - Scratch - Small / (L) Rear Fender, Molding - Scratch - Small / Trunk Hood, Rear Gate - Scratch - Small / Rear Bumper, Lamps, Panels - Scratch - Small / (R) Rear Door, Molding - Repair mark - Yes / (R) Rear Door, Molding - Scratch - Small / (R) Rear Fender, Molding - Repair mark - Yes / (R) Rear Fender, Molding - Scratch - Small / (R) Step, In-panel, Side Spoiler - Scratch &amp; Dent - Small / (R) Front Door, Molding - Scratch - Small / (R) Front Fender, Molding - Scratch - Small / (R) Mirror - Scratch - Minimal / Roof - Scratch &amp; Dent - Small / Bonnet, Headlight - Scratch - Small / (L) Mirror - Scratch - Minimal </div> </div> |

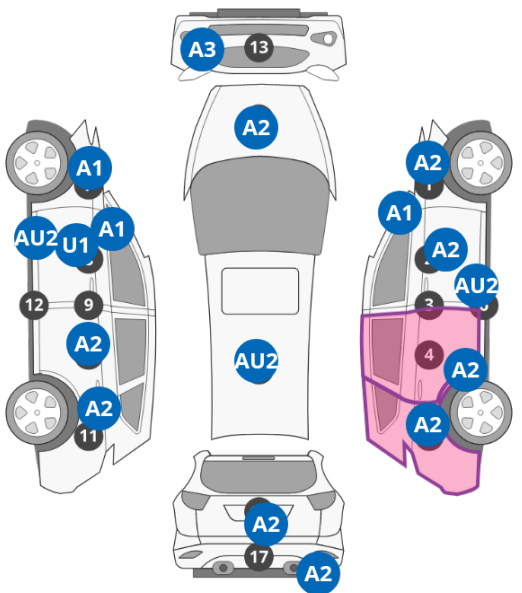
With LTO plate and Sparetire, No Tools and Jack and Warranty booklet, No spare key, worn tires and Sparetire, Scratch headlight and tail light.
