## General Information

| Make | Toyota | Model | Vios |

## Body / Panel Condition

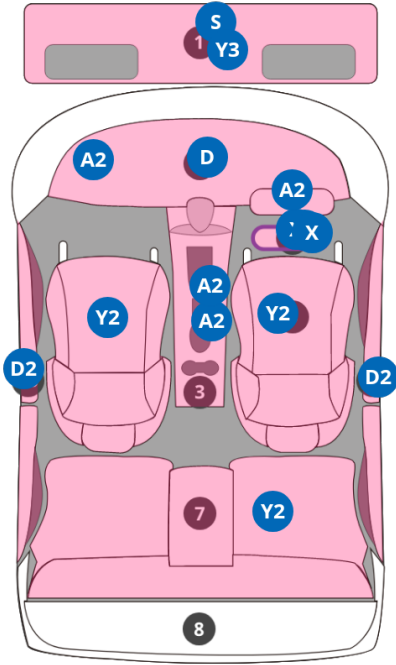
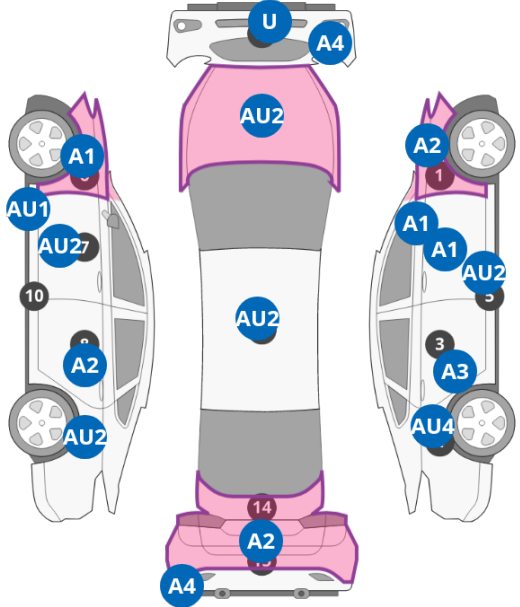
| Interior Evaluation : <span style="color: red;">C</span> | Exterior Evaluation : <span style="color: red;">E</span> |
| <p><b>Remarks</b></p> <p>(L) Front Floor Mat - Worked - Small / (R) Front Floor Mat - Missing - Yes / Mat Other - Missing - Yes / Overall Interior - Smell - Yes / Ceiling - Grime - Medium / Dashboard - Traces of Adhesive Tape - Yes / (L) Front Seat - Grime - Small / (R) Front Seat - Grime - Small / Rear Seat - Grime - Small / (L) Front Trim - Worked - Small / (R) Front Trim - Worked - Small / Console, Switchs, Vents - Worn, Scratch, Cut, Crack - Small / Knobs - Worn, Peel, Crack - Small / Steering Wheel - Worn, Peel, Crack - Small / Glove Box - Worn, Scratch, Cut, Crack - Small</p> | <p><b>Remarks</b></p> <p>(R) Front Fender - Repair Traces - Yes / Bonnet - Repair Traces - Yes / (L) Front Fender - Repair Traces - Yes / Trunk Hood, Rear Gate - Repair Traces - Yes / Trunk Hood, Rear Gate - Repair mark - Yes / Bonnet, Headlight - Repair mark - Yes / (L) Front Fender, Molding - Repair mark - Yes / (R) Front Fender, Molding - Repair mark - Yes / (R) Rear Fender, Molding - Scratch &amp; Dent - Large / (R) Rear Door, Molding - Scratch - Medium / (R) Front Door, Molding - Scratch - Minimal / (R) Step, In-panel, Side Spoiler - Scratch &amp; Dent - Small / (R) Front Fender, Molding - Scratch - Small / (R) Mirror - Scratch - Minimal / Trunk Hood, Rear Gate - Scratch - Small / Rear Bumper, Lamps, Panels - Scratch - Large / (L) Rear Fender, Molding - Scratch &amp; Dent - Small / (L) Rear Door, Molding - Scratch - Small / (L) Front Door, Molding - Scratch &amp; Dent - Small / (L) Step, In-panel, Side Spoiler - Scratch &amp; Dent - Minimal / (L) Front Fender, Molding - Scratch - Minimal / Member (Bolted) - Dent - Yes / Roof - Scratch &amp; Dent - Small / Bonnet, Headlight - Scratch &amp; Dent - Small / Front Bumper, Grille, Lamps - Scratch - Large</p> |

| Inspector Notes |
|---|
| <p>With LTO plate and Sparetire, No Tools and Jack and Warranty booklet, scratch headlight and tail light, damage tail light, no spare key, no reverse camera, foul smell, possible flooded ,worn tires and Sparetire, plate and room light issue, headlight issue and tail light issue.</p> |
