## General Information

| Make | Toyota | Model | Innova |
| Registration No. | NJF3860 | Chassis No. | PA2JA8EM9R0151248 |

## Body / Panel Condition

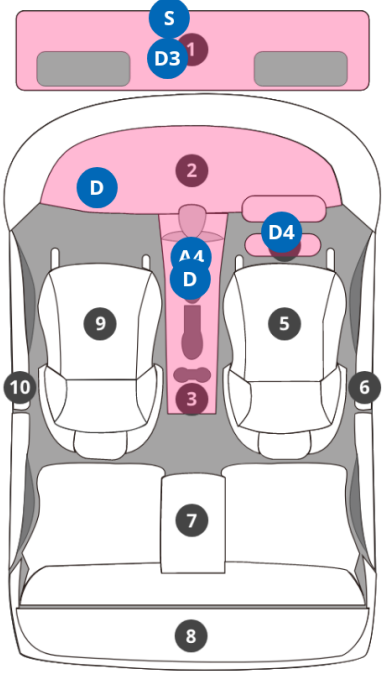
| Interior Evaluation : <span style="color: red;">C</span> | Exterior Evaluation : <span style="color: red;">E</span> |
| <p><b>Remarks</b><br/>(L) Front Floor Mat - Worked - Large / Knobs - Worn, Peel, Crack - Large / Dashboard - Traces of Adhesive Tape - Yes / Console, Switchs, Vents - Traces of Adhesive Tape - Yes / Overall Interior - Smell - Yes / Ceiling - Crinkle - Medium</p> | <p><b>Remarks</b><br/>(R) Front Fender - Repair Traces - Yes / Bonnet - Repair Traces - Yes / (L) Front Fender - Repair Traces - Yes / Trunk Hood, Rear Gate - Repair Traces - Yes / (L) Rear Fender, Molding - Repair mark - Yes / Member (Bolted) - Dent - Yes / (L) Front Fender, Molding - Repair mark - Yes / Bonnet, Headlight - Repair mark - Yes / (R) Front Fender, Molding - Repair mark - Yes / (L) Mirror - Scratch - Minimal / (L) Front Door, Molding - Scratch - Minimal / (L) Front Fender, Molding - Scratch &amp; Dent - Minimal / (L) Step, In-panel, Side Spoiler - Scratch &amp; Dent - Minimal / (L) Rear Fender, Molding - Scratch - Medium / Rear Bumper, Lamps, Panels - Scratch - Large / Trunk Hood, Rear Gate - Scratch &amp; Dent - Medium / (R) Rear Fender, Molding - Scratch - Small / (R) Rear Door, Molding - Scratch - Minimal / (R) Front Door, Molding - Scratch - Medium / (R) Mirror - Scratch - Minimal / (R) Front Fender, Molding - Scratch - Minimal / Bonnet, Headlight - Scratch &amp; Dent - Small / Front Bumper, Grille, Lamps - Scratch - Medium / Roof - Scratch &amp; Dent - Small / (R) Step, In-panel, Side Spoiler - Scratch &amp; Dent - Small</p> |
