## General Information

| Make | Toyota | Model | Vios |

## Body / Panel Condition

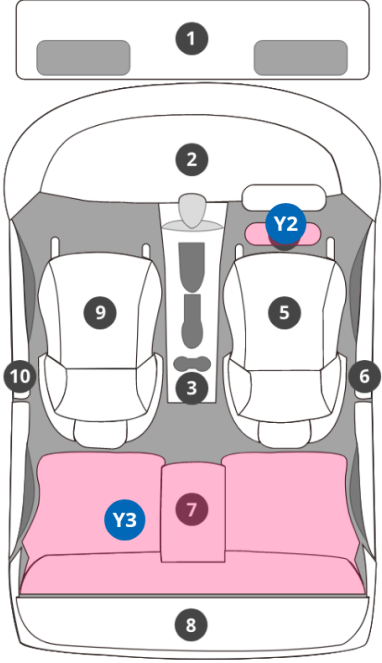
| Interior Evaluation : <b>B</b> | Exterior Evaluation : <b>C</b> |
| <p><b>Remarks</b><br/>Rear Seat - Grime - Medium / (L) Front Floor Mat - Grime - Small</p> | <p><b>Remarks</b><br/>(R) Front Door, Molding - Scratch &amp; Dent - Large / (R) Rear Door, Molding - Scratch &amp; Dent - Medium / (R) Rear Fender, Molding - Scratch &amp; Dent - Large / Rear Bumper, Lamps, Panels - Scratch &amp; Dent - Small / Trunk Hood, Rear Gate - Scratch &amp; Dent - Small / Front Bumper, Grille, Lamps - Scratch &amp; Dent - Medium / Bonnet, Headlight - Scratch - Minimal</p> |
