## General Information

| Make | Toyota | Model | Avanza |

## Body / Panel Condition

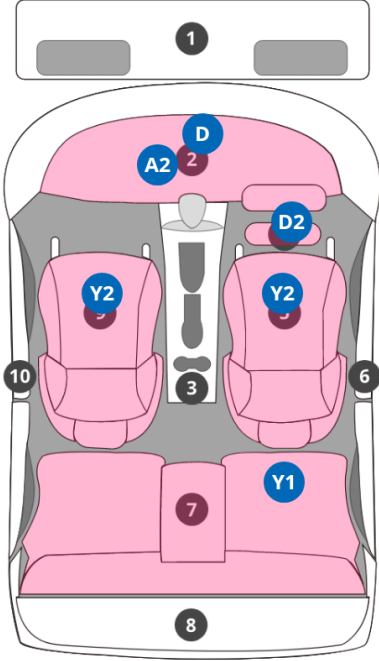
| Interior Evaluation : <b>B</b> | Exterior Evaluation : <b>D</b> |
| <b>Remarks</b><br>(L) Front Floor Mat - Worked - Small / Dashboard - Traces of Adhesive Tape - Yes / Dashboard - Worn, Scratch, Cut, Crack - Small / (L) Front Seat - Grime - Small / (R) Front Seat - Grime - Small / Rear Seat - Grime - Minimal | <b>Remarks</b><br>(R) Rear Door, Molding - Scratch & Dent - Medium / (R) Front Door, Molding - Scratch & Dent - Large / Front Bumper, Grille, Lamps - Scratch - Large / Bonnet, Headlight - Scratch - Small / (L) Front Fender, Molding - Scratch & Dent - Small / (L) Front Door, Molding - Scratch - Minimal / (L) Rear Door, Molding - Scratch & Dent - Minimal / (L) Step, In-panel, Side Spoiler - Scratch & Dent - Minimal / (L) Rear Fender, Molding - Scratch - Small / Trunk Hood, Rear Gate - Scratch & Dent - Small / Roof - Scratch & Dent - Small / (R) Rear Fender, Molding - Scratch & Dent - Minimal / (R) Step, In-panel, Side Spoiler - Scratch & Dent - Small / (R) Front Fender, Molding - Scratch - Small / (R) Mirror - Scratch - Minimal / (L) Mirror - Scratch - Minimal |

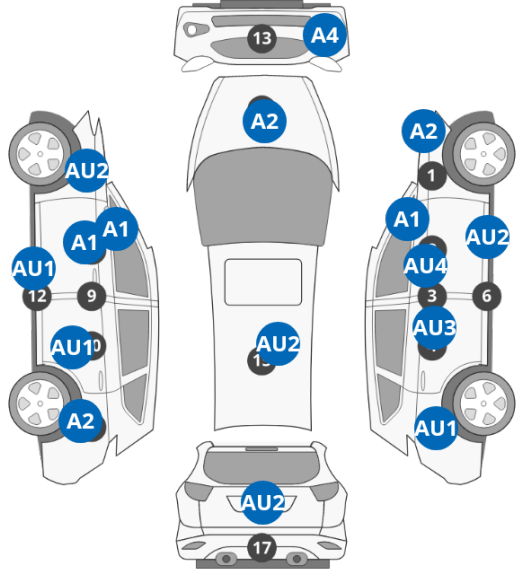
| Inspector Notes |
|---|
| With LTO plate, Sparetire, No Tools and Jack and Warranty booklet, scratch headlight and tail light. |
