## General Information

| Make | Toyota | Model | Vios |
| Registration No. | CCA9962 | Chassis No. | PA1B18F32R4262246 |

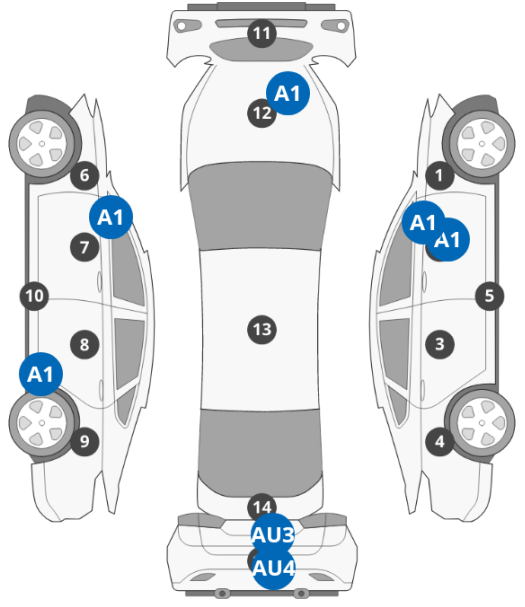
| Interior Evaluation : <b>A</b> | Exterior Evaluation : <b>C</b> |
| <b>Remarks</b><br>Defects not found | <b>Remarks</b><br>(R) Front Door, Molding - Scratch - Minimal / (R) Mirror - Scratch - Minimal / Rear Bumper, Lamps, Panels - Scratch & Dent - Large / Trunk Hood, Rear Gate - Scratch & Dent - Medium / (L) Step, In-panel, Side Spoiler - Scratch - Minimal / (L) Mirror - Scratch, Peeled - Minimal / Bonnet, Headlight - Scratch - Minimal |

With Lto plate, with warranty booklet, with jack, 1key,no spare tire, no tools, Crack head lights, Crack tail light,foul smell,possible flooded,
