## General Information

| Make | Toyota | Model | Wigo |
| YOM | 2025 | Odo Meter Reading | 12,679 |
| Registration No. | BAG6448 | Chassis No. | MHKAA1BC9RJ02665 |

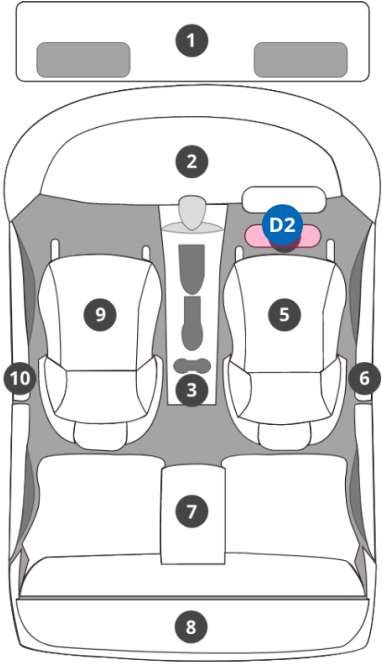
| Interior Evaluation : <span style="color: red; font-weight: bold;">A</span> | Exterior Evaluation : <span style="color: red; font-weight: bold;">C</span> |
| <b>Remarks</b><br>(L) Front Floor Mat - Worked - Small | <b>Remarks</b><br>(L) Front Fender, Molding - Scratch - Minimal / Front Bumper, Grille, Lamps - Scratch - Medium / (L) Front Door, Molding - Scratch - Minimal / (L) Mirror - Scratch - Minimal / (L) Rear Door, Molding - Scratch - Minimal / (L) Step, In-panel, Side Spoiler - Scratch & Dent - Minimal / (L) Rear Fender, Molding - Scratch - Minimal / Roof - Scratch & Dent - Small / Trunk Hood, Rear Gate - Scratch - Small / Rear Bumper, Lamps, Panels - Scratch - Small / (R) Rear Fender, Molding - Scratch - Minimal / (R) Rear Door, Molding - Scratch - Small / (R) Front Door, Molding - Scratch - Minimal / (R) Step, In-panel, Side Spoiler - Scratch & Dent - Minimal / (R) Front Fender, Molding - Scratch - Minimal / Bonnet, Headlight - Scratch & Dent - Minimal / (R) Mirror - Scratch - Minimal |

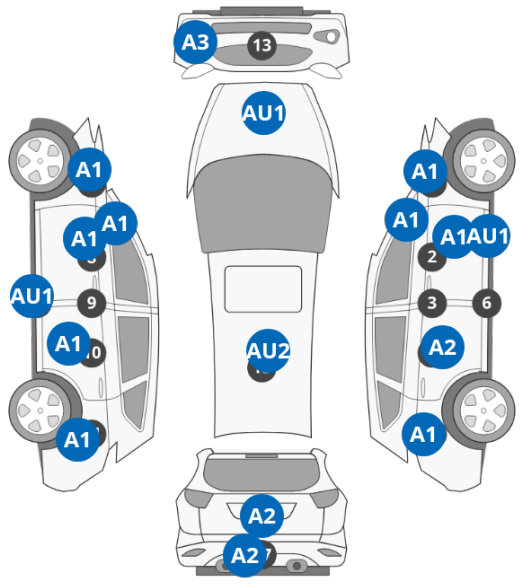
| Inspector Notes |
|---|
| With LTO plate and Sparetire and Warranty booklet, No Tools and Jack, Scratch headlight and tail light, Worn Tires and Sparetire. |
