## General Information

| Make | Toyota | Model | Vios |
| Registration No. | DBF9979 | Chassis No. | PA1B18F30R4255487 |

## Body / Panel Condition

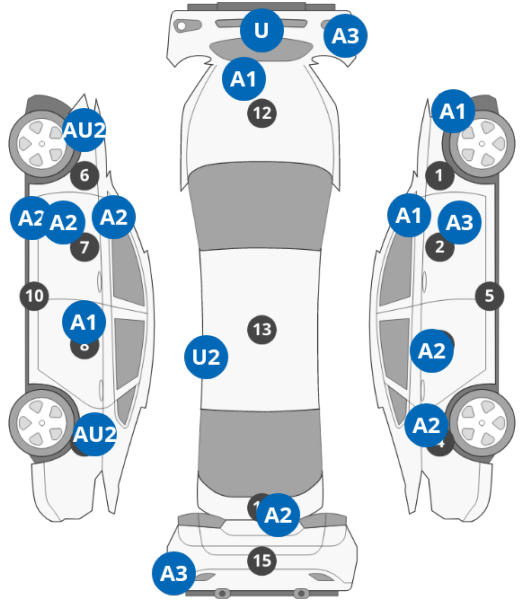
| <b>Remarks</b><br>(R) Front Seat - Grime - Small / (L) Front Seat - Worn - Yes / Rear Seat - Grime - Medium / (R) Front Floor Mat - Grime - Small / (L) Front Trim - Grime - Small / (L) Front Floor Mat - Worked - Small / Ceiling - Grime - Minimal | <b>Remarks</b><br>(L) Rear Door - Repair Traces - Yes / (R) Front Fender, Molding - Scratch - Minimal / (R) Front Door, Molding - Scratch - Medium / (R) Rear Door, Molding - Scratch - Small / (R) Mirror - Scratch - Minimal / (R) Rear Fender, Molding - Scratch - Small / Rear Bumper, Lamps, Panels - Scratch - Medium / Trunk Hood, Rear Gate - Scratch - Small / (L) Rear Fender, Molding - Scratch & Dent - Small / (L) Step, In-panel, Side Spoiler - Scratch - Small / (L) Rear Door, Molding - Scratch - Minimal / (L) Front Door, Molding - Scratch - Small / (L) Mirror - Scratch - Small / (L) Front Fender, Molding - Scratch & Dent - Small / Member (Bolted) - Dent - Yes / Front Bumper, Grille, Lamps - Scratch - Medium / Bonnet, Headlight - Scratch - Minimal / Roof - Dent - Small |

| Inspector Notes |
|---|
| no warranty booklet, with jack and tools, with spare tire, with LTO plate, scratches on tail light |
