## General Information

| Make | Toyota | Model | Vios |

## Body / Panel Condition

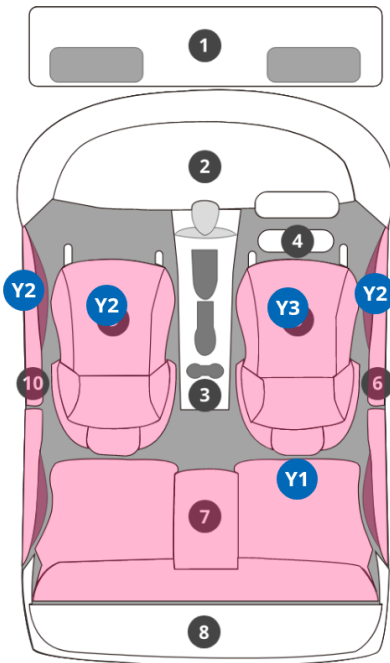
| Interior Evaluation : <b>B</b> | Exterior Evaluation : <b>A</b> |
|---|---|
| <p><b>Remarks</b><br/>Rear Seat - Grime - Minimal / (R) Front Seat - Grime - Medium / (R) Front Trim - Grime - Small / (L) Front Trim - Grime - Small / (L) Front Seat - Grime - Small</p> | <p><b>Remarks</b><br/>(R) Mirror - Scratch - Minimal / (R) Front Fender, Molding - Scratch - Minimal / Rear Bumper, Lamps, Panels - Scratch - Minimal / Roof - Scratch - Minimal</p> |
