## General Information

| Make | Toyota | Model | Vios |
| Registration No. | NEY7236 | Chassis No. | PA1B18F39R4263247 |

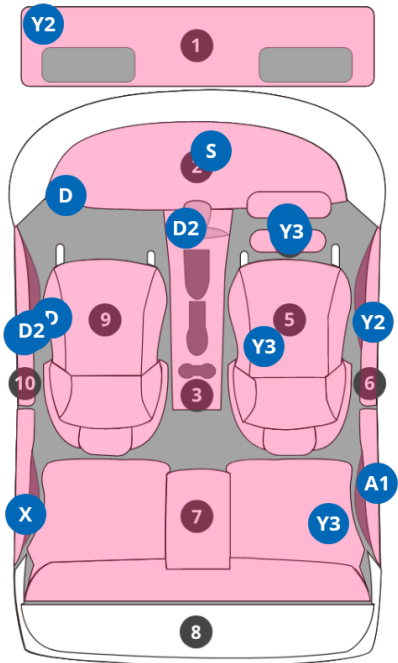
| Interior Evaluation : <b>D</b> | Exterior Evaluation : <b>E</b> |
|---|---|
| <p><b>Remarks</b></p> <p>(R) Front Seat - Grime - Medium / (L) Front Seat - Worn - Yes / Rear Seat - Grime - Medium / Ceiling - Grime - Small / (R) Front Trim - Grime - Small / (R) Rear Trim - Cut, Crack - Minimal / Trim Other - Missing - Yes / (L) Front Trim - Grime - Medium / (L) Front Trim - Worked - Small / Dashboard - Traces of Adhesive Tape - Yes / (L) Front Floor Mat - Worked - Small / (L) Front Floor Mat - Cut, Crack - Small / (R) Front Floor Mat - Grime - Small / Mat Other - Grime - Medium / Overall Interior - Smell - Yes / Console, Switches, Vents - Loose, Deformed - Small</p> | <p><b>Remarks</b></p> <p>(R) Front Fender - Repair Traces - Yes / Bonnet - Repair Traces - Yes / Trunk Hood, Rear Gate - Repair Traces - Yes / (R) Mirror - Scratch - Small / (R) Front Fender, Molding - Dent - Medium / (R) Rear Door, Molding - Scratch &amp; Dent - Large / (R) Front Door, Molding - Scratch &amp; Dent - Large / (R) Step, In-panel, Side Spoiler - Scratch &amp; Dent - Large / (R) Rear Fender, Molding - Scratch - Large / Rear Bumper, Lamps, Panels - Scratch &amp; Dent - Medium / Trunk Hood, Rear Gate - Scratch - Small / (L) Rear Door, Molding - Scratch - Medium / (L) Front Door, Molding - Scratch - Small / (L) Rear Fender, Molding - Scratch &amp; Dent - Small / (L) Mirror - Scratch - Small / Member (Bolted) - Dent - Yes / (L) Front Fender, Molding - Scratch &amp; Dent - Medium / Bonnet, Headlight - Dent - Medium / Bonnet, Headlight - Repair mark - Yes / Front Bumper, Grille, Lamps - Repair mark - Yes / Front Bumper, Grille, Lamps - Modified - Small / Front Bumper, Grille, Lamps - Scratch &amp; Dent - Large / Roof - Dent - Minimal</p> |

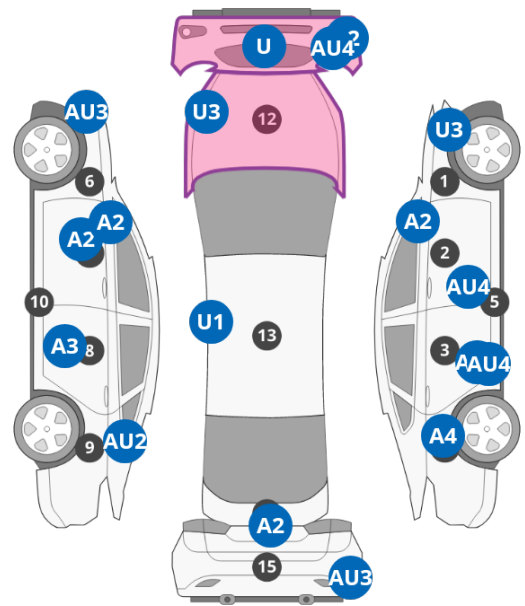
| Inspector Notes |
|---|
| <p>no warranty booklet, with jack, no tools, no spare tire, with LTO plate, scratched and cracked tail light, reverse and plate light issue, headlight low beam issue, turn signal/hazard flasher issue, brake issue, traction control indicator ON, dome light issue, steering wheel issue, loose trunk hood and right side mirror</p> |
