## General Information

| Make | Toyota | Model | Vios |
| Registration No. | NHI2738 | Chassis No. | PA1B18F32P4204571 |

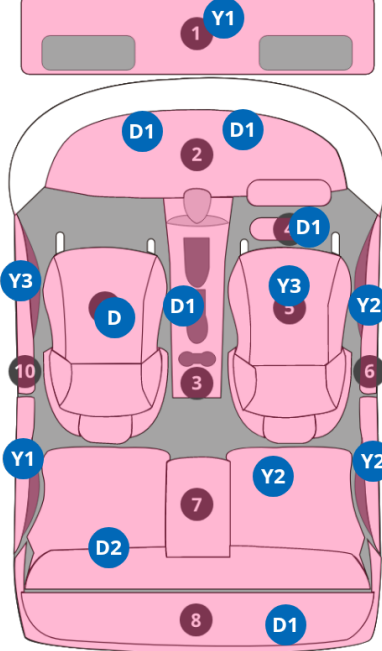
| Interior Evaluation : <b>C</b> | Exterior Evaluation : <b>E</b> |
|---|---|
| <b>Remarks</b><br>(R) Front Trim - Grime - Small / Carpet - Worked - Minimal / (R) Front Seat - Grime - Medium / (L) Front Seat - Worn - Yes / Console, Switchs, Vents - Worked - Minimal / Glove Box - Worked - Minimal / Dashboard - Worked - Minimal / Rear Seat - Grime - Small / (R) Rear Trim - Grime - Small / (L) Rear Trim - Grime - Minimal / (L) Front Trim - Grime - Medium / Rear Seat Head Rest - Worked - Small / Trunk Room - Worked - Minimal / Ceiling - Grime - Minimal | <b>Remarks</b><br>(L) Front Door - Repair Traces - Yes / (L) Step - Repair Traces - Yes / (L) Rear Door - Repair Traces - Yes / Trunk Hood, Rear Gate - Repair Traces - Yes / (R) Rear Fender, Molding - Scratch & Dent - Medium / Rear Bumper, Lamps, Panels - Scratch - Small / Trunk Hood, Rear Gate - Repair mark - Yes / Overall Exterior - Full Re-Paint in same color - Yes / Roof - Scratch - Small / (L) Front Door, Molding - Scratch & Dent - Medium / (L) Front Fender, Molding - Scratch & Dent - Medium / Front Bumper, Grille, Lamps - Scratch & Dent - Medium / (R) Front Fender, Molding - Scratch - Medium / (R) Front Door, Molding - Scratch - Medium / (R) Rear Door, Molding - Scratch & Dent - Large / (L) Rear Fender, Molding - Repair mark - Yes / (L) Rear Fender, Molding - Scratch - Minimal / (L) Rear Door, Molding - Repair mark - Yes / Bonnet, Headlight - Scratch - Medium |
