## General Information

| Make | Toyota | Model | Vios |

## Body / Panel Condition

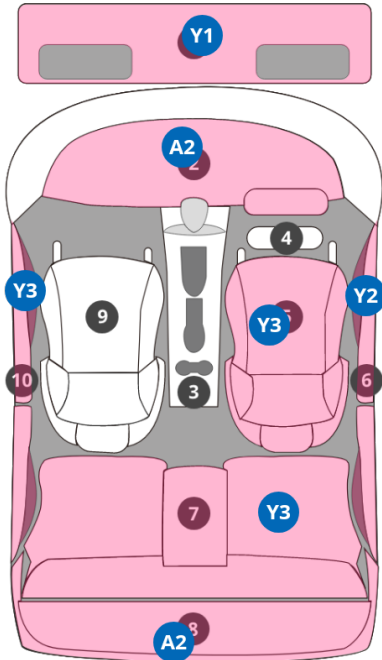
| Interior Evaluation : <span style="color: red; font-weight: bold;">C</span> | | Exterior Evaluation : <span style="color: red; font-weight: bold;">C</span> | |
| <p><b>Remarks</b></p> <p>Rear Seat - Grime - Medium / (R) Front Seat - Grime - Medium / (R) Front Trim - Grime - Small / Trunk Room - Worn, Scratch, Cut, Crack - Small / (L) Front Trim - Grime - Medium / Dashboard - Worn, Scratch, Cut, Crack - Small / Ceiling - Grime - Minimal</p> | | <p><b>Remarks</b></p> <p>Bonnet, Headlight - Scratch - Minimal / Front Bumper, Grille, Lamps - Scratch - Medium / (R) Front Door, Molding - Scratch - Small / (R) Rear Fender, Molding - Scratch - Small / (R) Rear Door, Molding - Scratch - Minimal / Rear Bumper, Lamps, Panels - Scratch - Large / Trunk Hood, Rear Gate - Scratch - Small / (L) Rear Fender, Molding - Scratch &amp; Dent - Small / (L) Front Fender, Molding - Scratch - Minimal / (L) Mirror - Scratch - Minimal / (L) Front Door, Molding - Scratch - Medium / (L) Rear Door, Molding - Scratch - Minimal / Roof - Scratch - Minimal / (R) Front Fender, Molding - Scratch - Minimal</p> | |
