## General Information

| Make | Toyota | Model | Vios |
| YOM | 2021 | Mileage | 57,432 |
| Registration No. | DAU3414 | Chassis No. | PA1B18F31M4134945 |

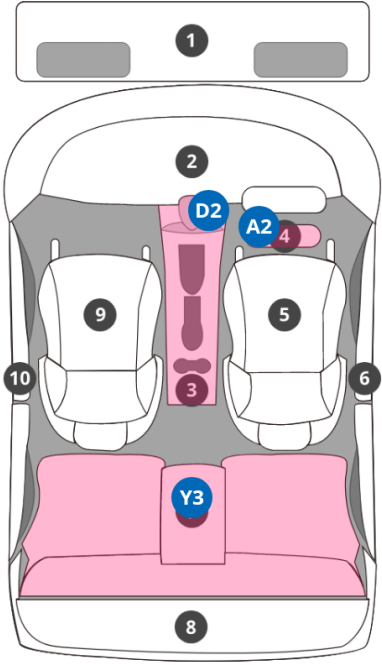
| Interior Evaluation : <b>B</b> | Exterior Evaluation : <b>C</b> |
|---|---|
| <p><b>Remarks</b><br/>(L) Front Floor Mat - Cut, Crack - Small / Rear Seat - Grime - Medium / Console, Switchs, Vents - Loose, Deformed - Small</p> | <p><b>Remarks</b><br/>(R) Front Fender - Repair Traces - Yes / Bonnet - Repair Traces - Yes / (L) Front Fender - Repair Traces - Yes / (L) Step - Repair Traces - Yes / Trunk Hood, Rear Gate - Repair Traces - Yes / Roof - Repair Traces - Yes / (L) Front Fender, Molding - Scratch &amp; Dent - Minimal / (R) Front Fender, Molding - Scratch &amp; Dent - Small / (R) Rear Door, Molding - Scratch &amp; Dent - Medium / (R) Front Door, Molding - Scratch &amp; Dent - Minimal / (R) Rear Fender, Molding - Dent - Minimal / Rear Bumper, Lamps, Panels - Scratch &amp; Dent - Medium / Roof - Crack, Gap - Medium / (L) Rear Door, Molding - Dent - Medium / (L) Step, In-panel, Side Spoiler - Scratch &amp; Dent - Large / Front Bumper, Grille, Lamps - Scratch - Small / Bonnet, Headlight - Dent - Minimal</p> |
