## General Information

| Make | Toyota | Model | Vios |
| YOM | 2024 | Odo Meter Reading | 62,105 |
| Registration No. | NEY4101 | Chassis No. | PA1B18F3XR4259964 |

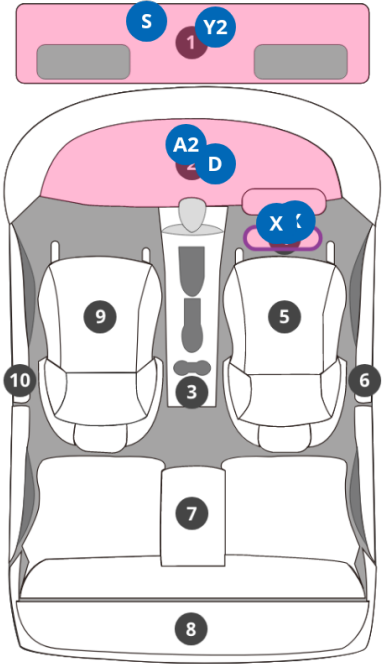
| Interior Evaluation : <b>B</b> | Exterior Evaluation : <b>D</b> |
| <p><b>a</b> : Cut, Fray <b>d</b> : Loose, Deformed <b>k</b> : Animal Hair <b>s</b> : Smell <b>t</b> : Cigarette Burns <b>x</b> : Defective <b>y</b> : Stain</p> | <p><b>A</b> : Scratch <b>AU</b> : Scratch &amp; Dent <b>B</b> : Modified <b>C</b> : Corrosion <b>G</b> : Stone chip <b>P</b> : Faded <b>S</b> : Rust <b>SC</b> : Rust &amp; Corrosion <b>U</b> : Dent <b>X</b> : Defective <b>Y</b> : Crack, Gap</p> |
| <p><b>Remarks</b></p> <p>(L) Front Floor Mat - Missing - Yes / (R) Front Floor Mat - Missing - Yes / Mat Other - Missing - Yes / Ceiling - Grime - Small / Overall Interior - Smell - Yes / Dashboard - Traces of Adhesive Tape - Yes / Dashboard - Worn, Scratch, Cut, Crack - Small</p> | <p><b>Remarks</b></p> <p>(R) Front Fender - Repair Traces - Yes / (L) Front Fender - Repair Traces - Yes / (L) Front Fender, Molding - Repair mark - Yes / (R) Front Fender, Molding - Repair mark - Yes / (R) Rear Door, Molding - Dent - Small / (R) Front Door, Molding - Scratch &amp; Dent - Small / (R) Step, In-panel, Side Spoiler - Scratch &amp; Dent - Minimal / (R) Front Fender, Molding - Scratch - Small / (R) Rear Fender, Molding - Scratch &amp; Dent - Small / Member (Bolted) - Dent - Yes / Bonnet, Headlight - Scratch &amp; Dent - Small / Front Bumper, Grille, Lamps - Scratch - Small / (L) Rear Door, Molding - Scratch &amp; Dent - Medium / (L) Step, In-panel, Side Spoiler - Scratch &amp; Dent - Small / (L) Front Door, Molding - Scratch &amp; Dent - Small / (L) Mirror - Scratch - Minimal / (L) Front Fender, Molding - Scratch - Small / Roof - Scratch &amp; Dent - Small / Trunk Hood, Rear Gate - Scratch &amp; Dent - Small / (L) Rear Fender, Molding - Scratch - Small / Rear Bumper, Lamps, Panels - Scratch - Small</p> |
