## General Information

| Make | Toyota | Model | Vios |
| YOM | 2025 | Odo Meter Reading | 9,212 |
| Registration No. | CCG4559 | Chassis No. | PA1B18F35R4269241 |

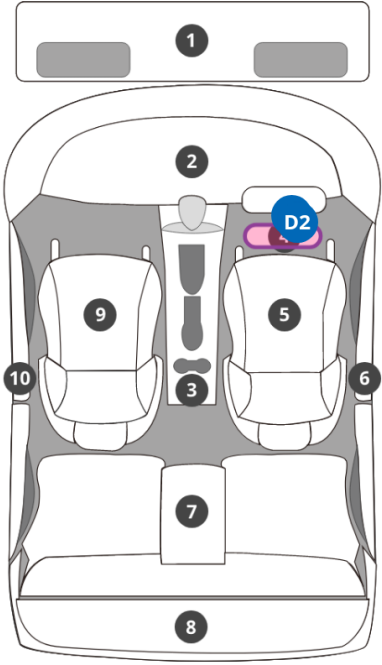
| Interior Evaluation : <b>B</b> | Exterior Evaluation : <b>B</b> |
|---|---|
| <b>Remarks</b><br>Mat Other - Missing - Yes / (L) Front Floor Mat - Worked - Small | <b>Remarks</b><br>Member (Bolted) - Dent - Yes / (L) Front Fender, Molding - Scratch - Small / (L) Front Door, Molding - Scratch - Minimal / (L) Rear Door, Molding - Scratch & Dent - Minimal / (L) Rear Fender, Molding - Scratch - Small / Roof - Scratch & Dent - Small / Trunk Hood, Rear Gate - Scratch - Small / (R) Rear Door, Molding - Scratch & Dent - Small / (R) Front Door, Molding - Scratch - Small / (R) Front Fender, Molding - Scratch - Minimal / Bonnet, Headlight - Scratch & Dent - Small / Front Bumper, Grille, Lamps - Scratch - Small |
