## General Information

| Make | Toyota | Model | Avanza |

## Body / Panel Condition

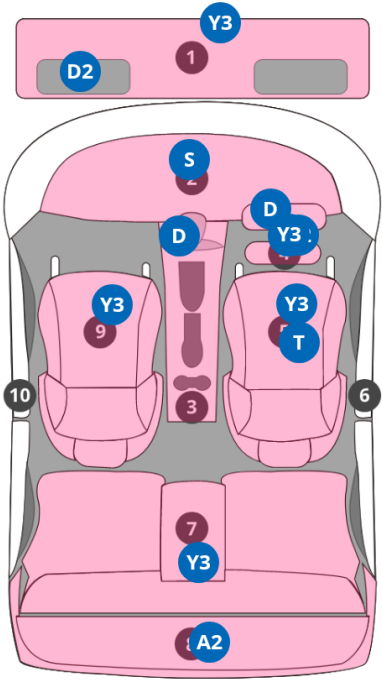
| Interior Evaluation : <b>E</b> | Exterior Evaluation : <b>E</b> |
|---|---|
| <b>Remarks</b><br>(R) Front Seat - Cigarette Burns - Burnt, Hole / (R) Front Seat - Grime - Medium / (L) Front Seat - Grime - Medium / Rear Seat - Grime - Medium / Trunk Room - Worn, Scratch, Cut, Crack - Small / Ceiling - Grime - Medium / Overall Interior - Smell - Yes / Overall Interior - Worn as per age - Yes / Console, Switches, Vents - Traces of Adhesive Tape - Yes / Dashboard - Traces of Adhesive Tape - Yes / (R) Front Floor Mat - Grime - Small / (L) Front Floor Mat - Worked - Small / Mat Other - Grime - Medium / Sunvisor, Sunglass Holder - Crinkle - Small | <b>Remarks</b><br>(R) Front Fender, Molding - Scratch & Dent - Medium / (R) Mirror - Scratch - Medium / (R) Mirror - Stuck - Yes / (R) Step, In-panel, Side Spoiler - Scratch & Dent - Large / (R) Front Door, Molding - Scratch & Dent - Medium / (R) Rear Door, Molding - Scratch & Dent - Large / (R) Rear Fender, Molding - Scratch & Dent - Small / Rear Bumper, Lamps, Panels - Scratch & Dent - Medium / Trunk Hood, Rear Gate - Scratch & Dent - Small / (L) Rear Fender, Molding - Scratch & Dent - Large / (L) Step, In-panel, Side Spoiler - Scratch & Dent - Medium / (L) Rear Door, Molding - Scratch & Dent - Large / (L) Front Door, Molding - Scratch - Large / (L) Mirror - Scratch - Small / (L) Front Fender, Molding - Scratch & Dent - Medium / Front Bumper, Grille, Lamps - Scratch & Dent - Large / Bonnet, Headlight - Crack, Gap - Medium / Roof - Scratch - Medium / (R) Front Door, Molding - Repair mark - Yes / (R) Rear Door, Molding - Repair mark - Yes / (L) Rear Fender, Molding - Repair mark - Yes / (L) Rear Door, Molding - Repair mark - Yes / (L) Front Door, Molding - Repair mark - Yes / (L) Front Fender, Molding - Repair mark - Yes / Front Bumper, Grille, Lamps - Repair mark - Yes |

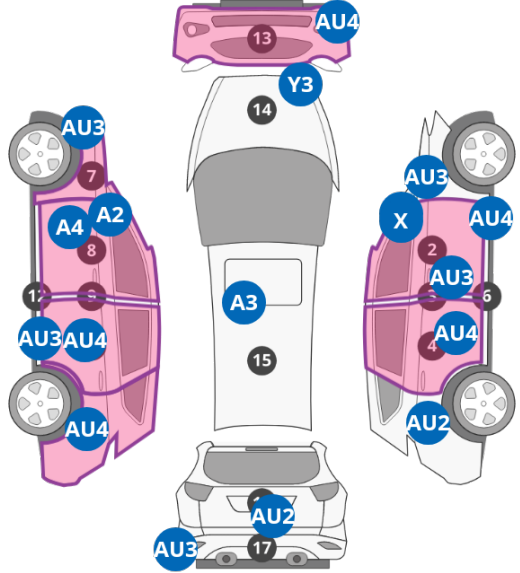
| Inspector Notes |
|---|
| no warranty booklet, no jack and tools, with spare tire, with LTO plate, scratches on headlight and tail, cracked tail light, possible flooding, right side mirror issue and partially missing, check engine warning lamp and traction control indicator ON, rear door lock issue, adhesive mark on left and right air vents |
